HISTORICAL PHOTOGRAPHS

PHOTOGRAPHS

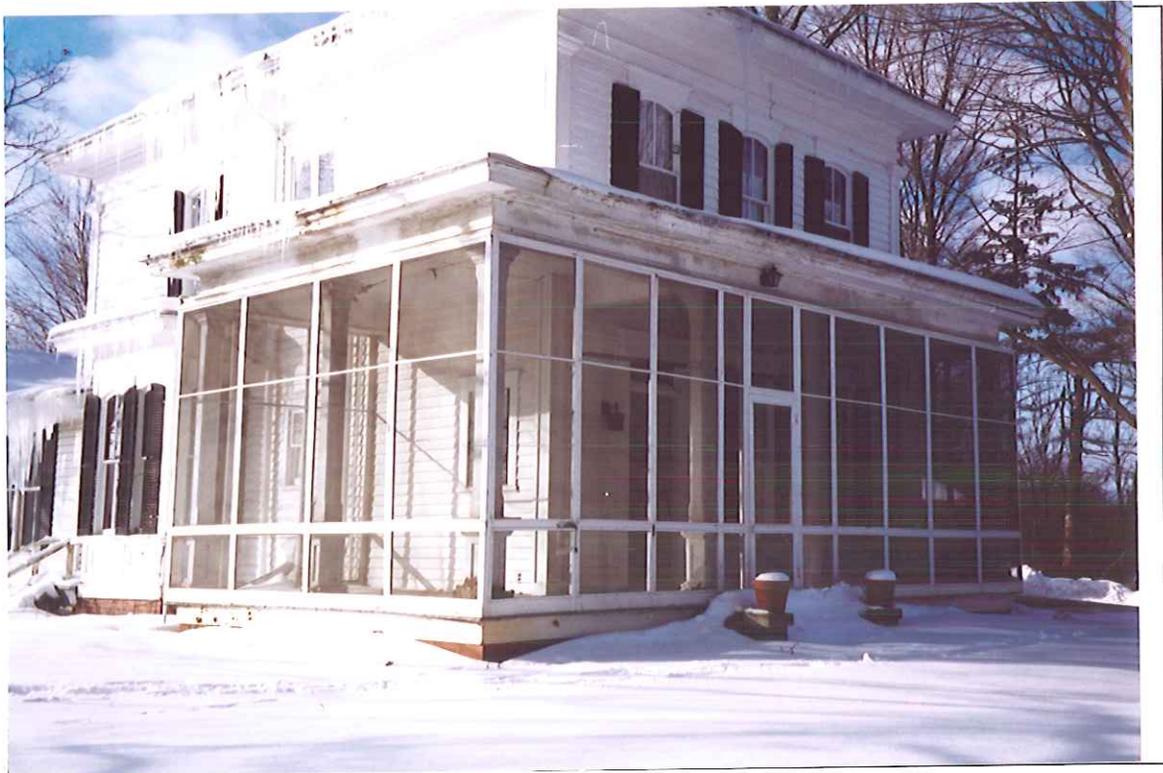
Northeast corner of the house and screen porch. Note the ice dams at the eaves and the mildew on the trim boards.

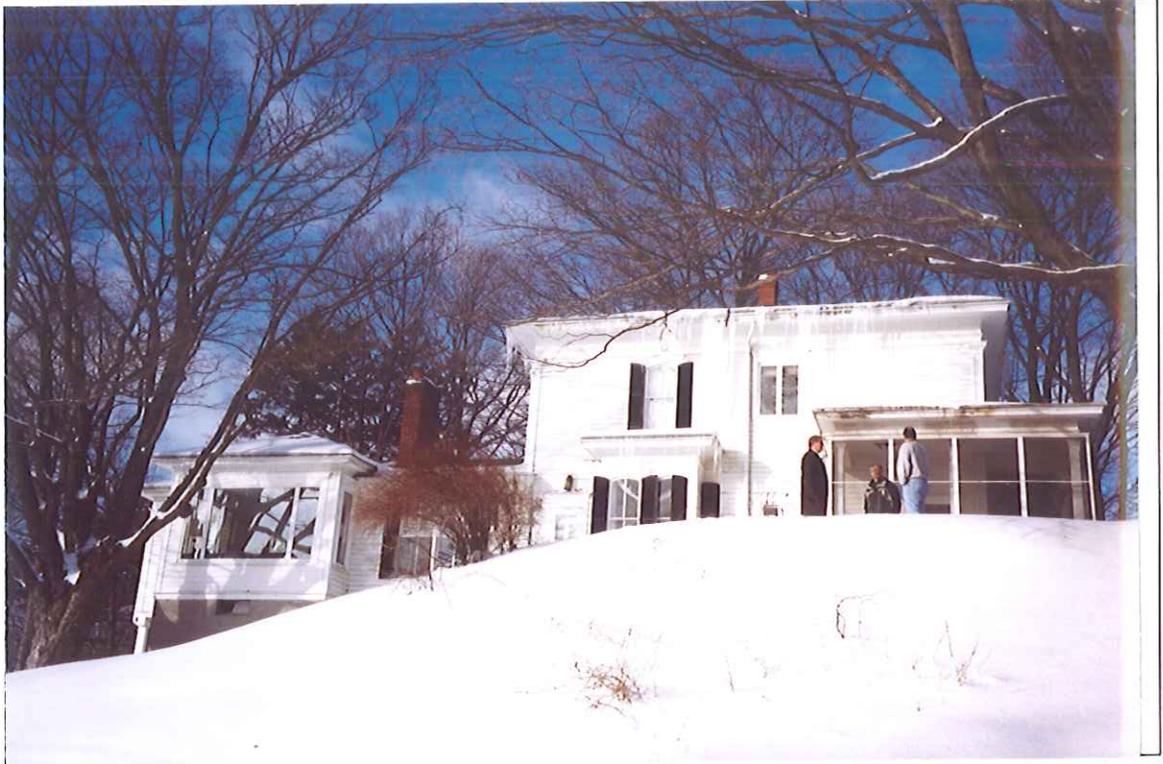
East façade of the house; note the ice dams at the eaves and the addition at the rear of the building.

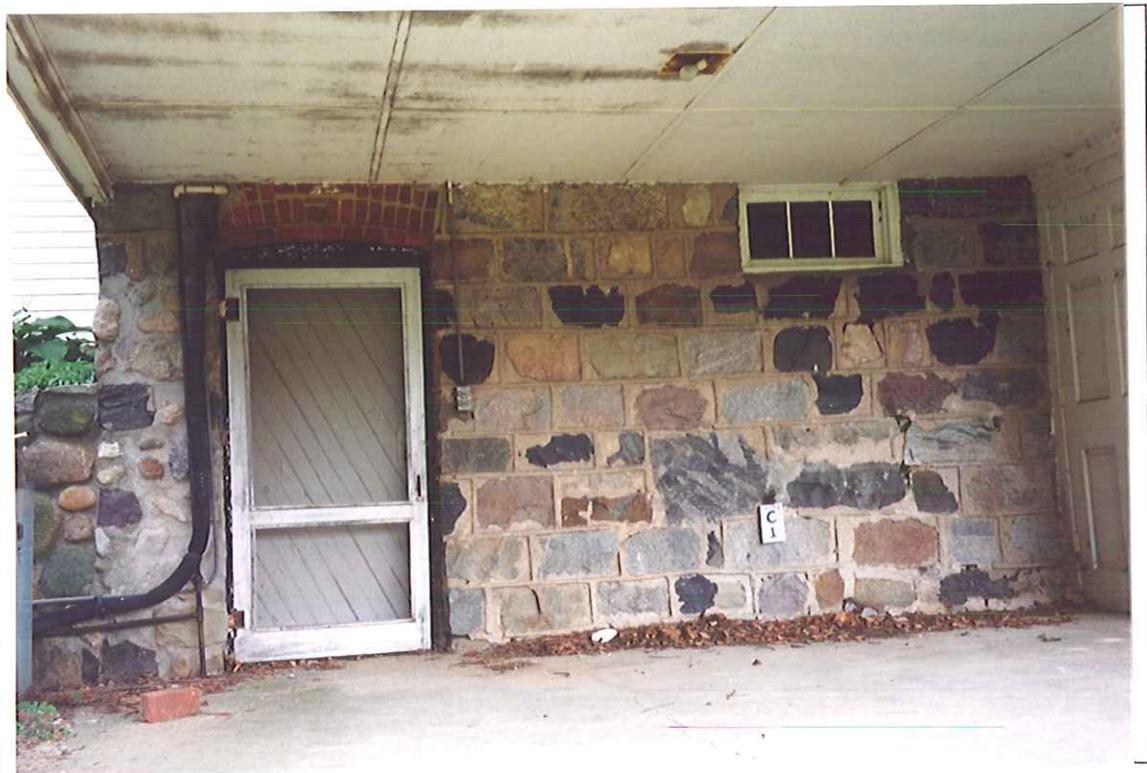
South wall of the original basement foundation. Note the cantilevered addition and mildewed soffit boards above the wall.

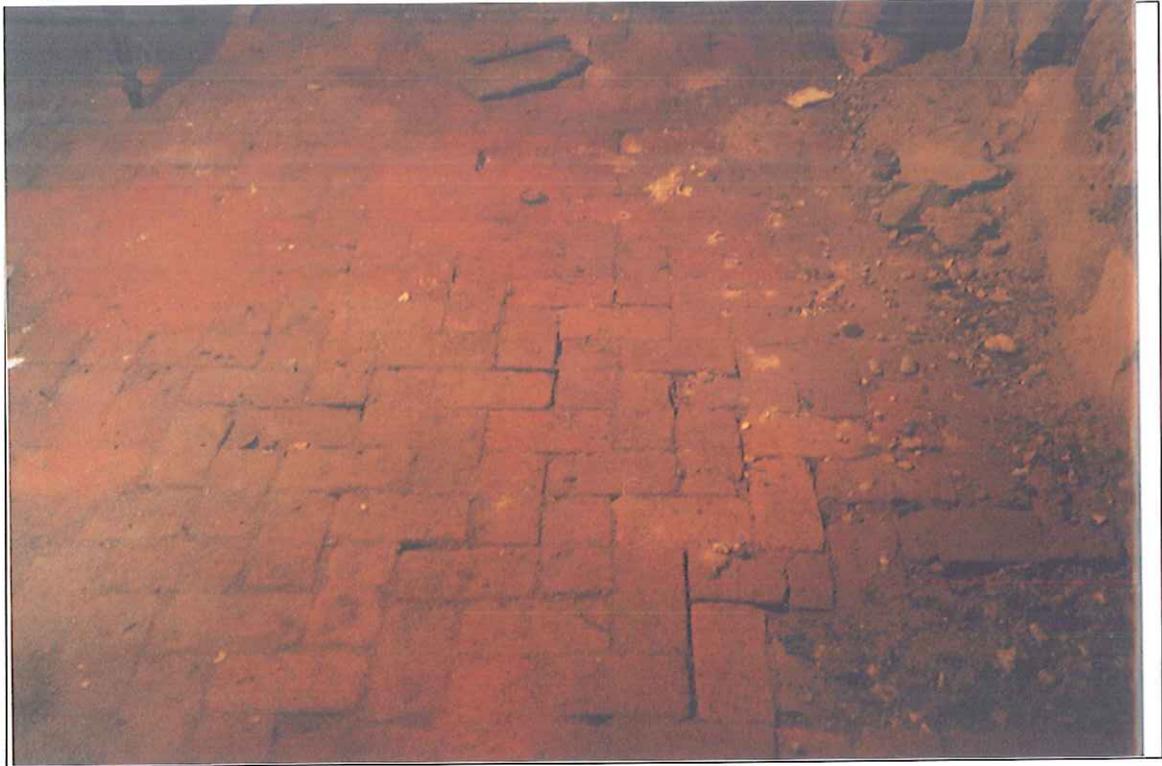
Deteriorating brick floor in basement.

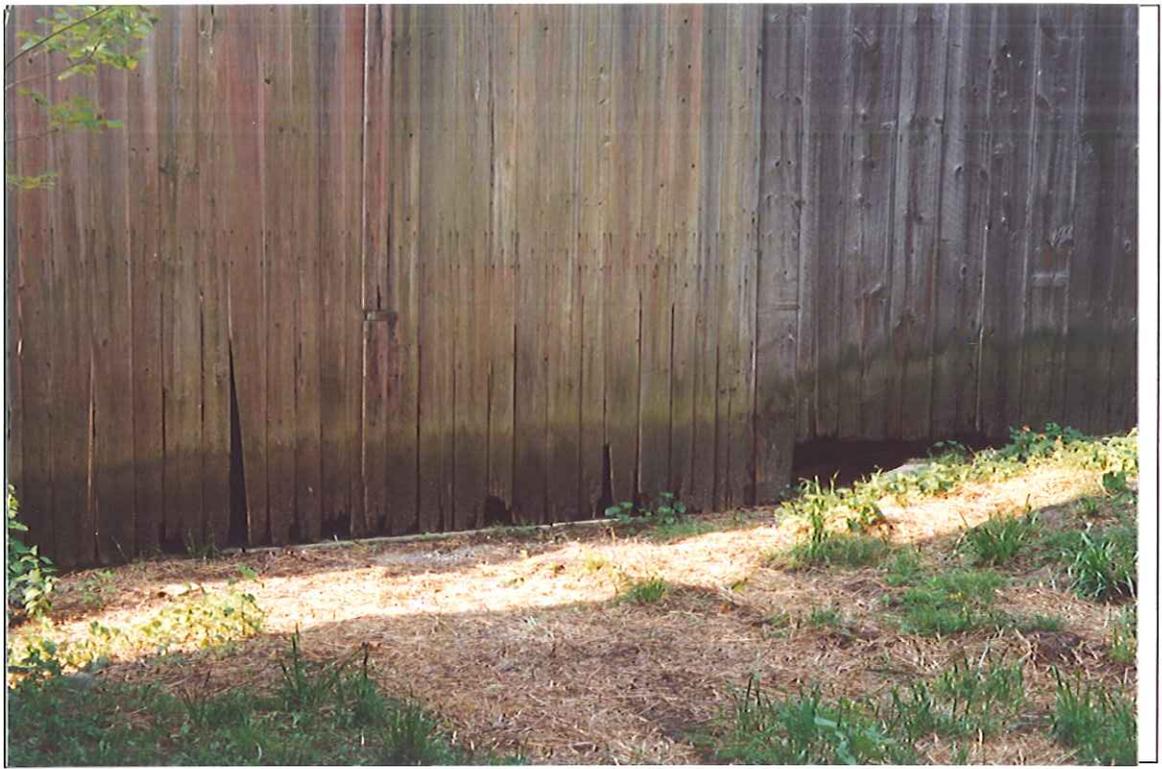
North elevation of the gray barn showing the damage at grade of the center bay entry doors and the west bay.

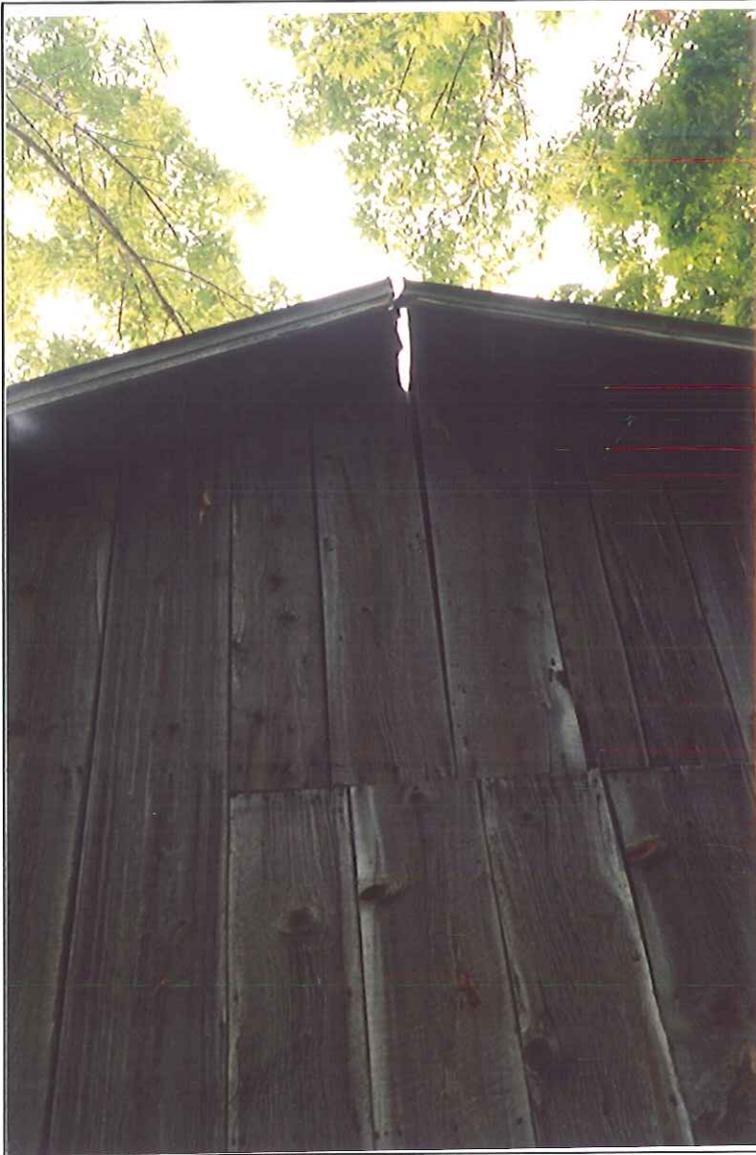
West gable end of the gray barn showing the separation of materials.

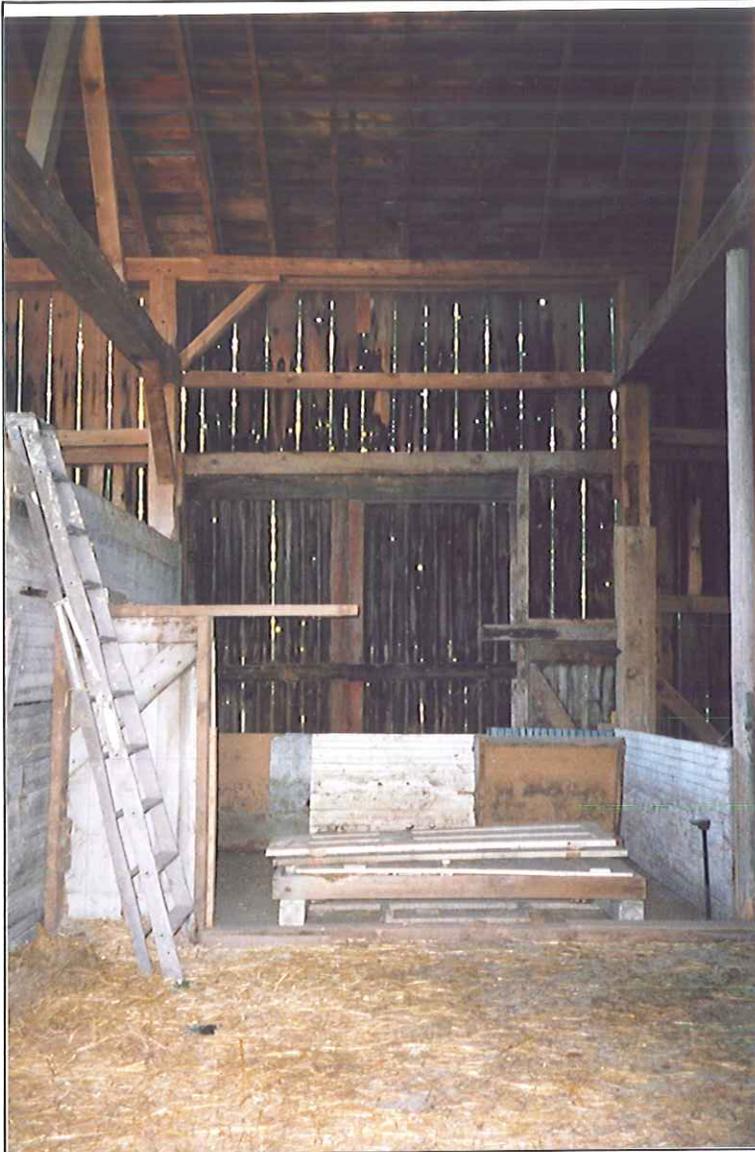
Interior of the gray barn looking from the north entry to the damaged south wall and west bay.

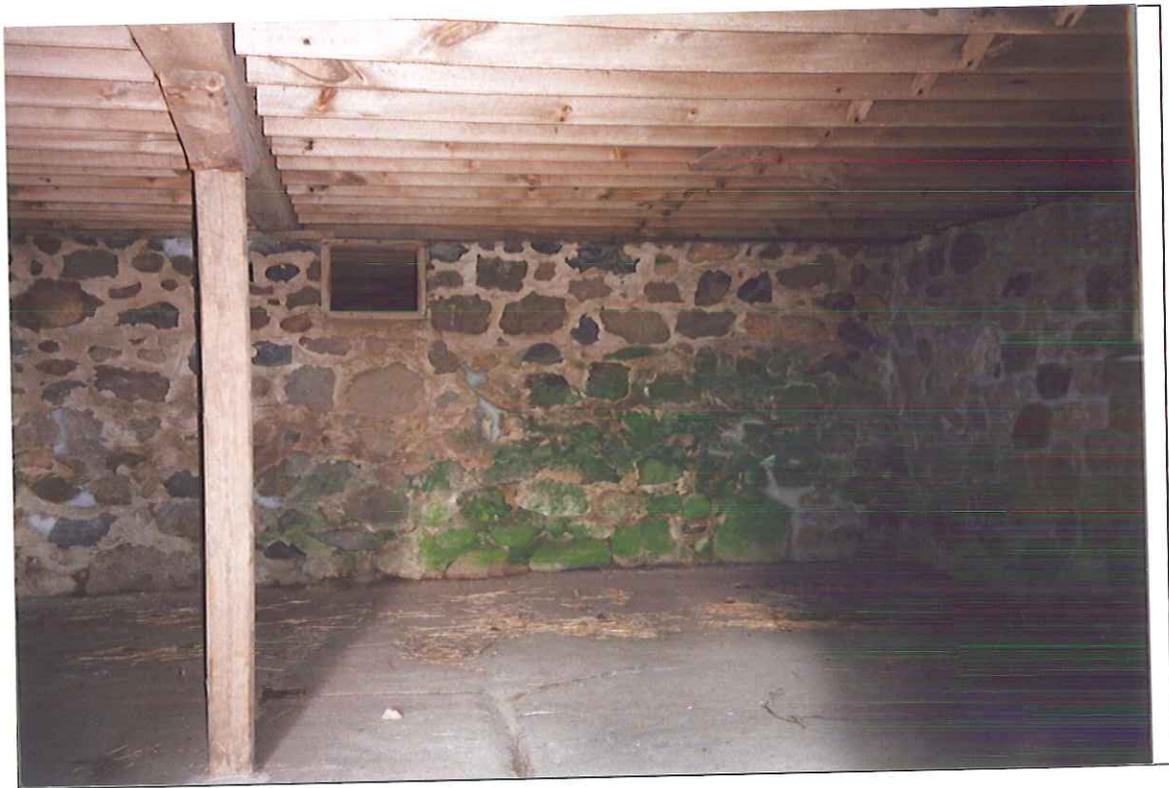
West wall of the basement of the red barn. Note the organic growth on the stones.
