Cultural Landscape Report:

**The Van Raalte Farm
In
Holland, Michigan**

Prepared by J. Brian Devlin
January 2006

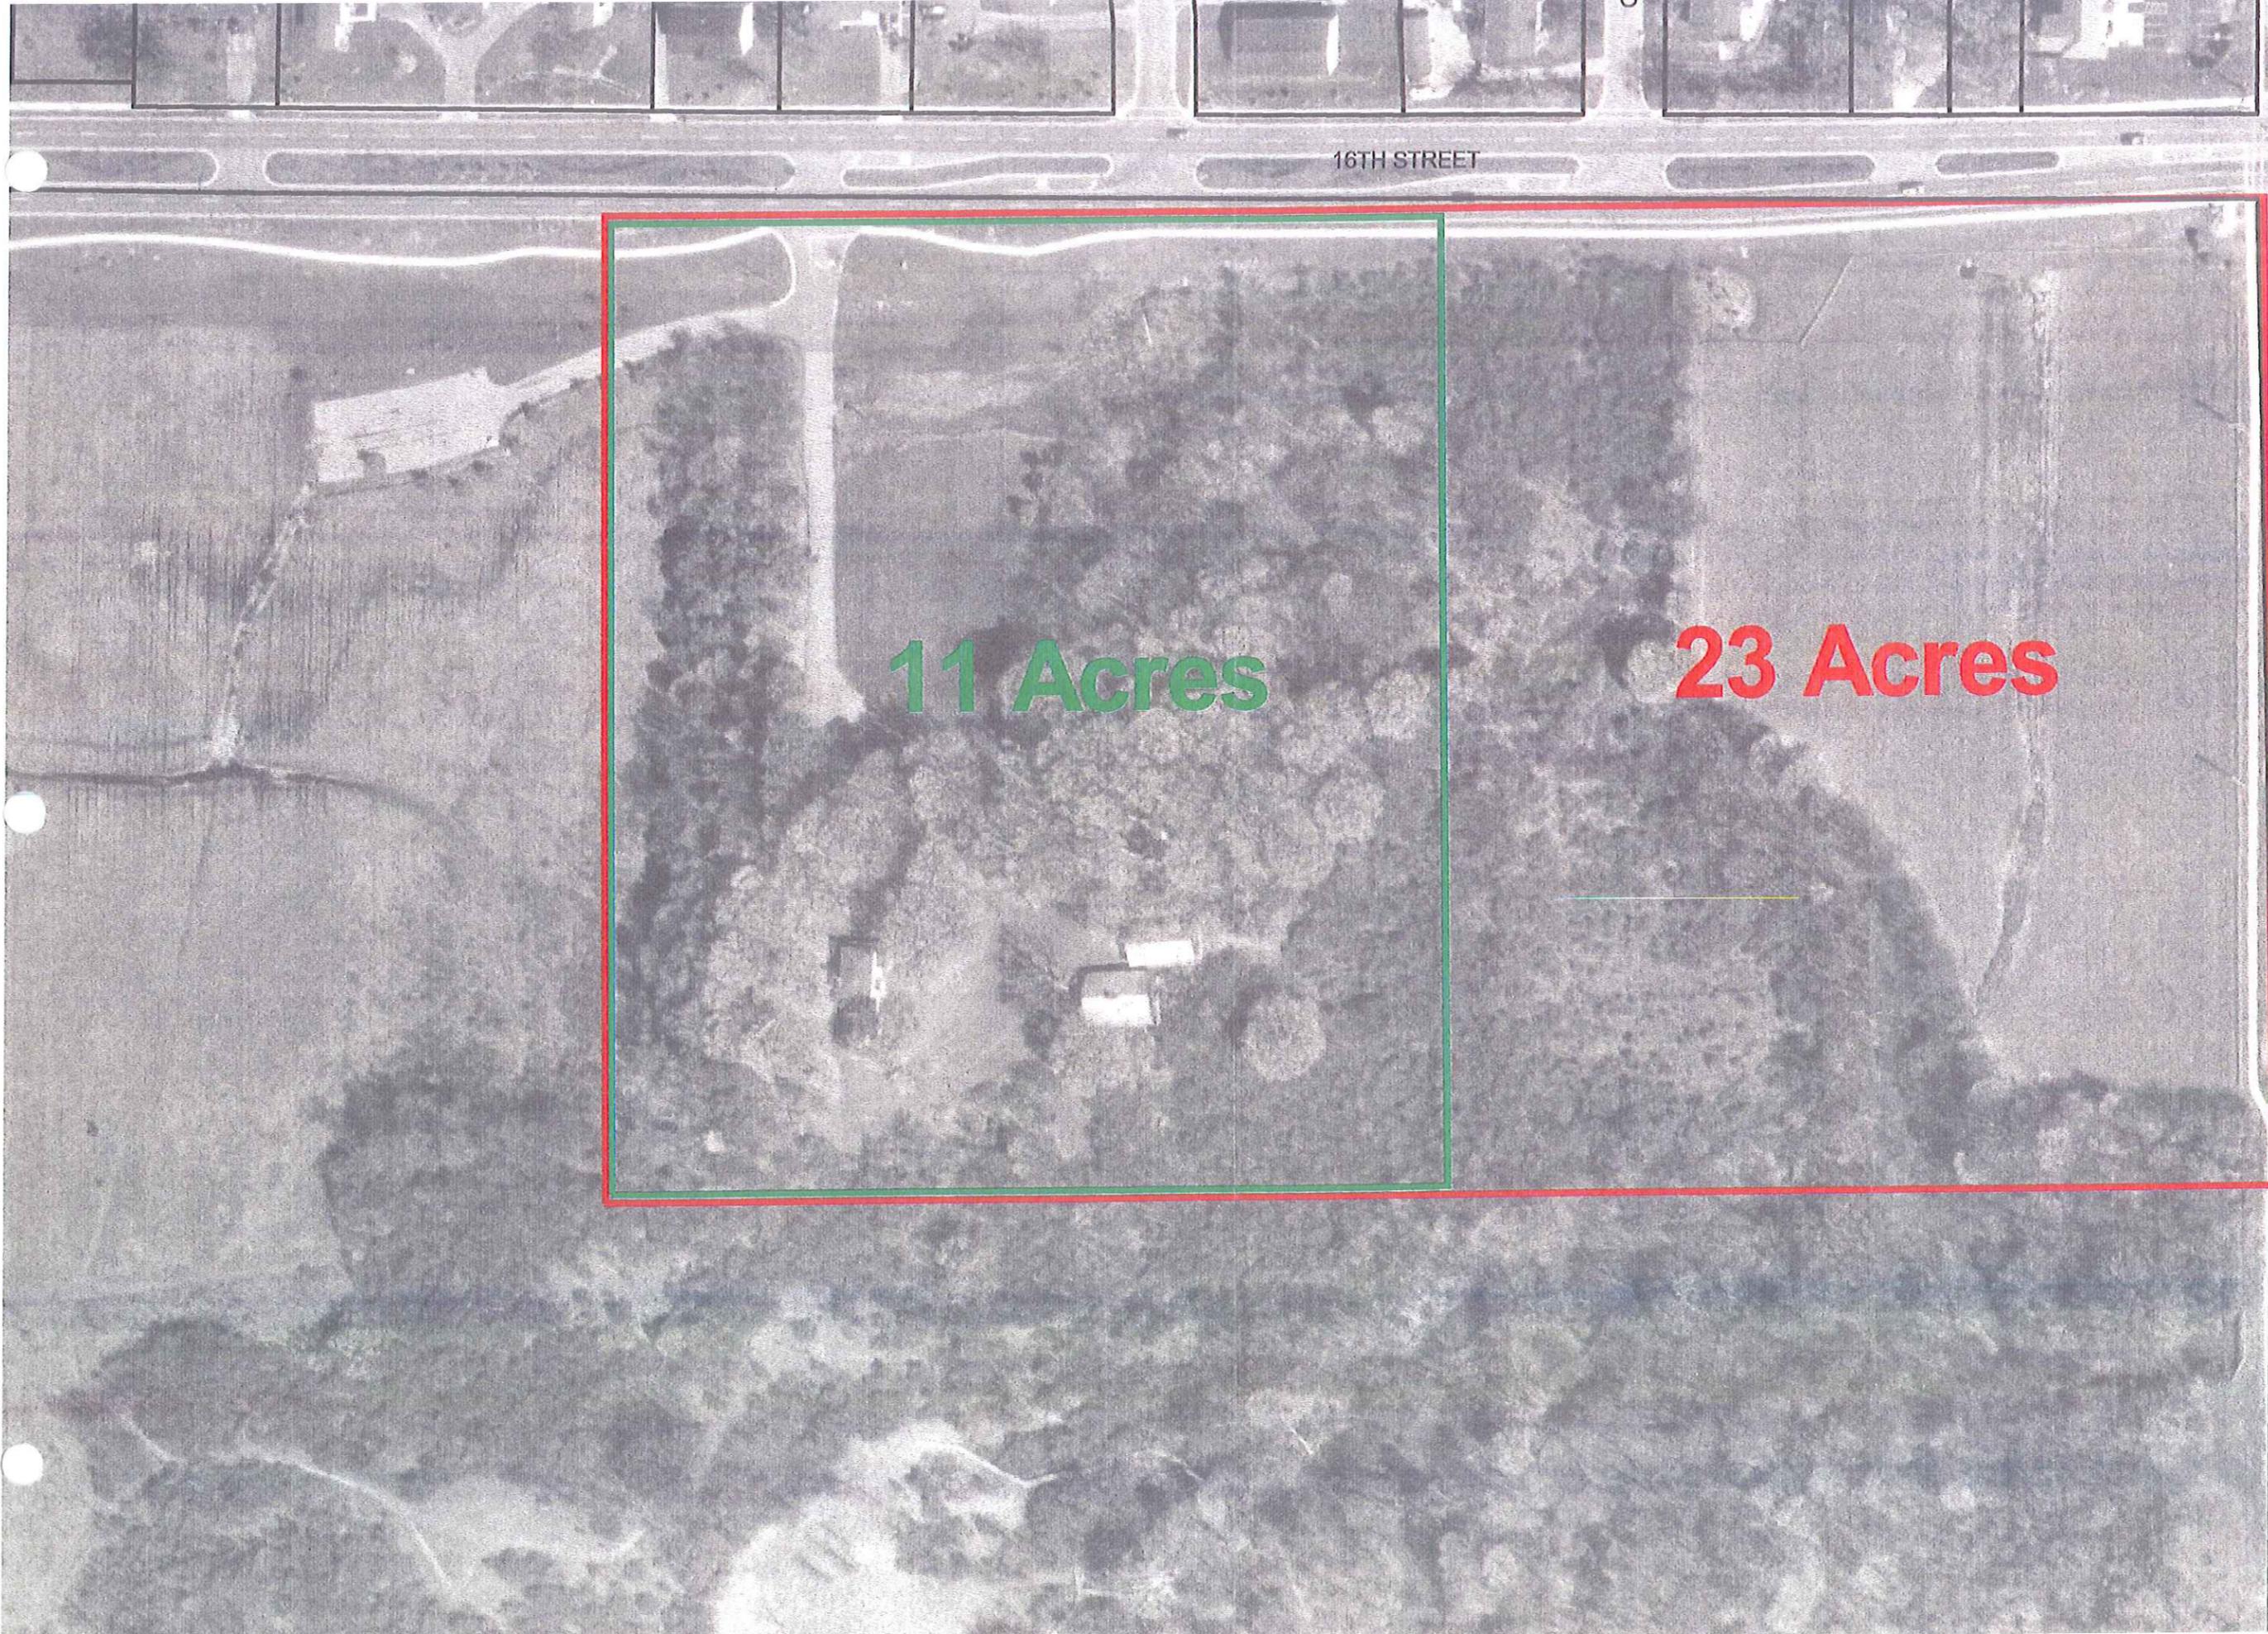
Figure 2: Northeast corner of the park property including the historic home lot.
(Source: City of Holland)

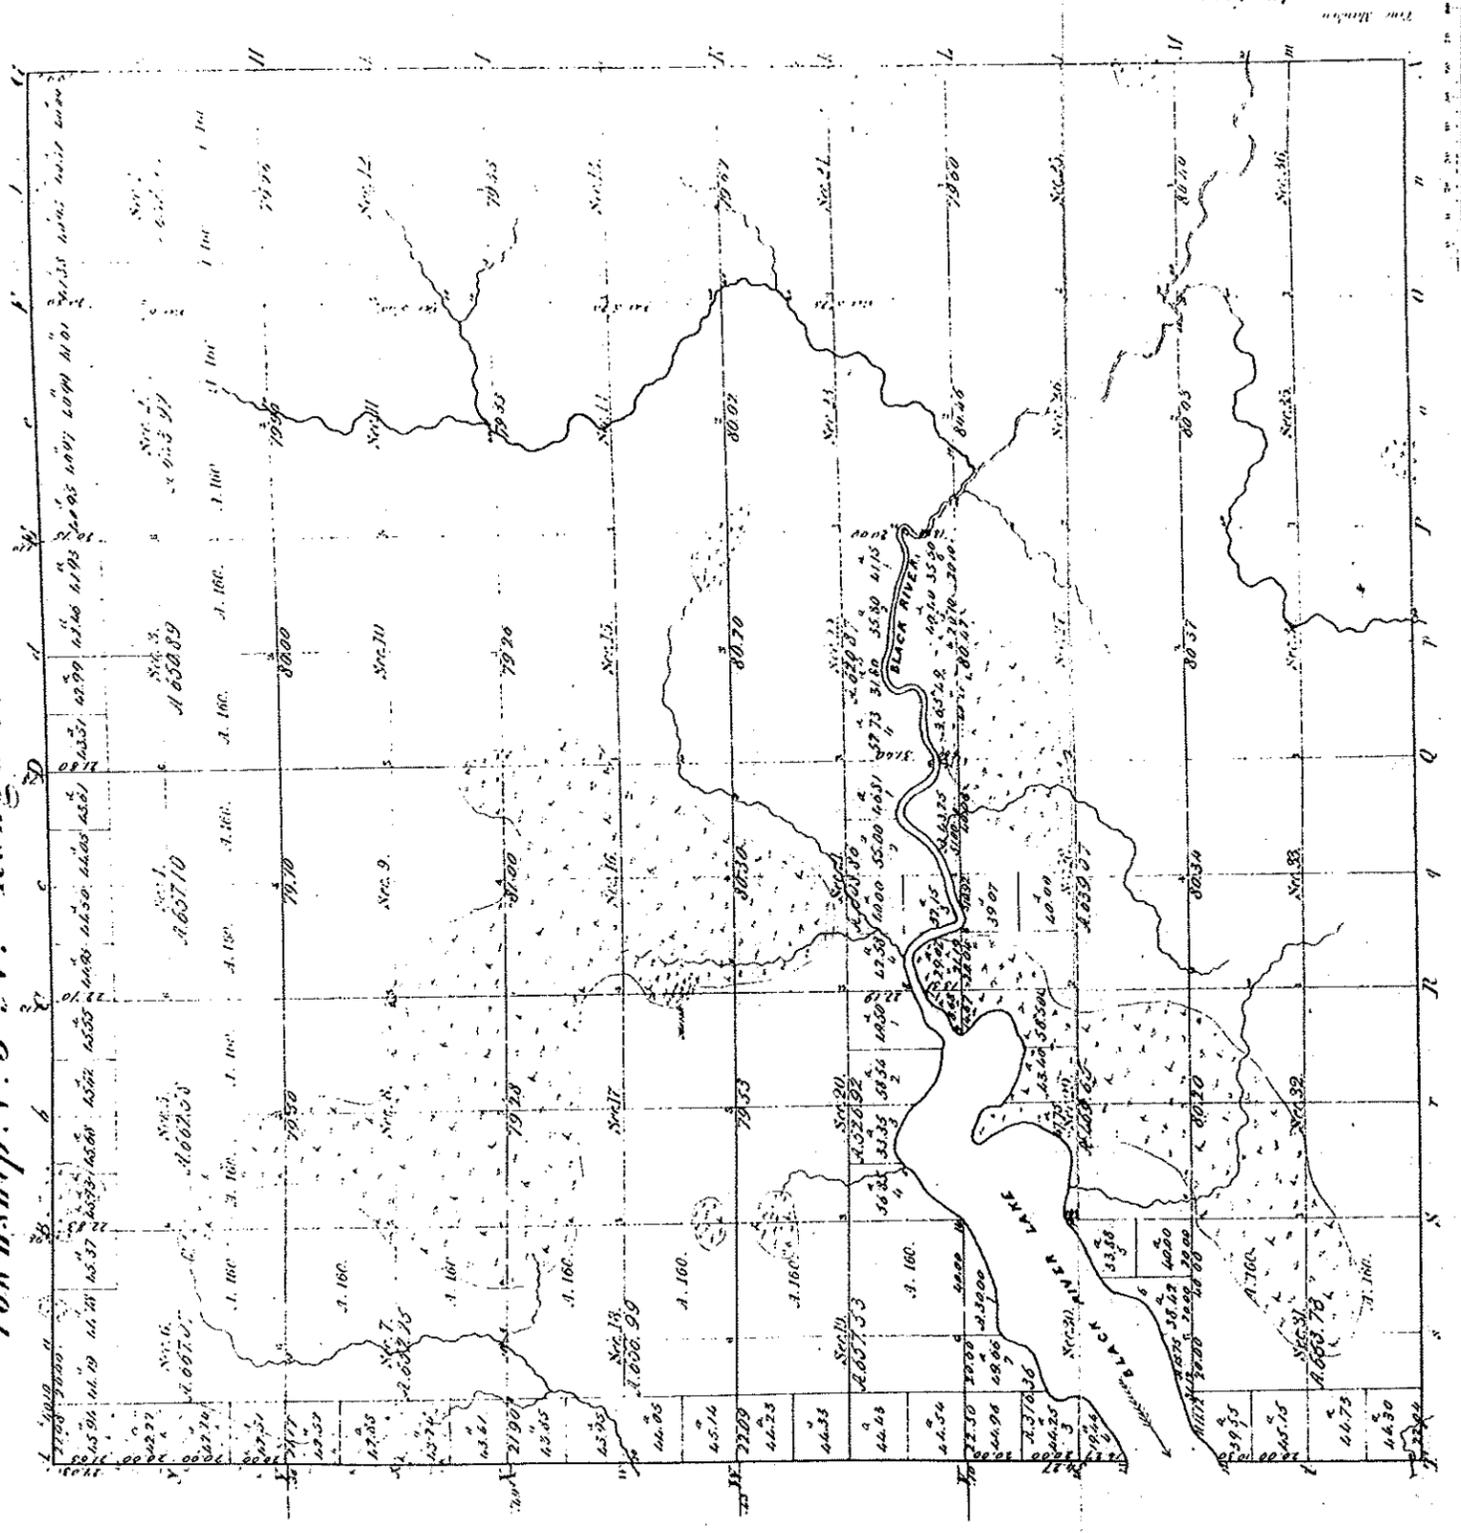
Surveyed in 1832 by C. Brittain Deputy Surveyor.

Figure 3: An early survey of the area around the Black River and the Black River Lake. (Source: The Holland Museum Archives.)

An early survey map (Figure 3) shows large areas of wetland near the Black River Lake and to the north of the river. The map of the Holland Settlement in 1849 (Figure 4) shows the first areas of development at the east end of the Black River Lake. Also depicted on this map are roads, churches, saw mills, wind mill, and Indian village.

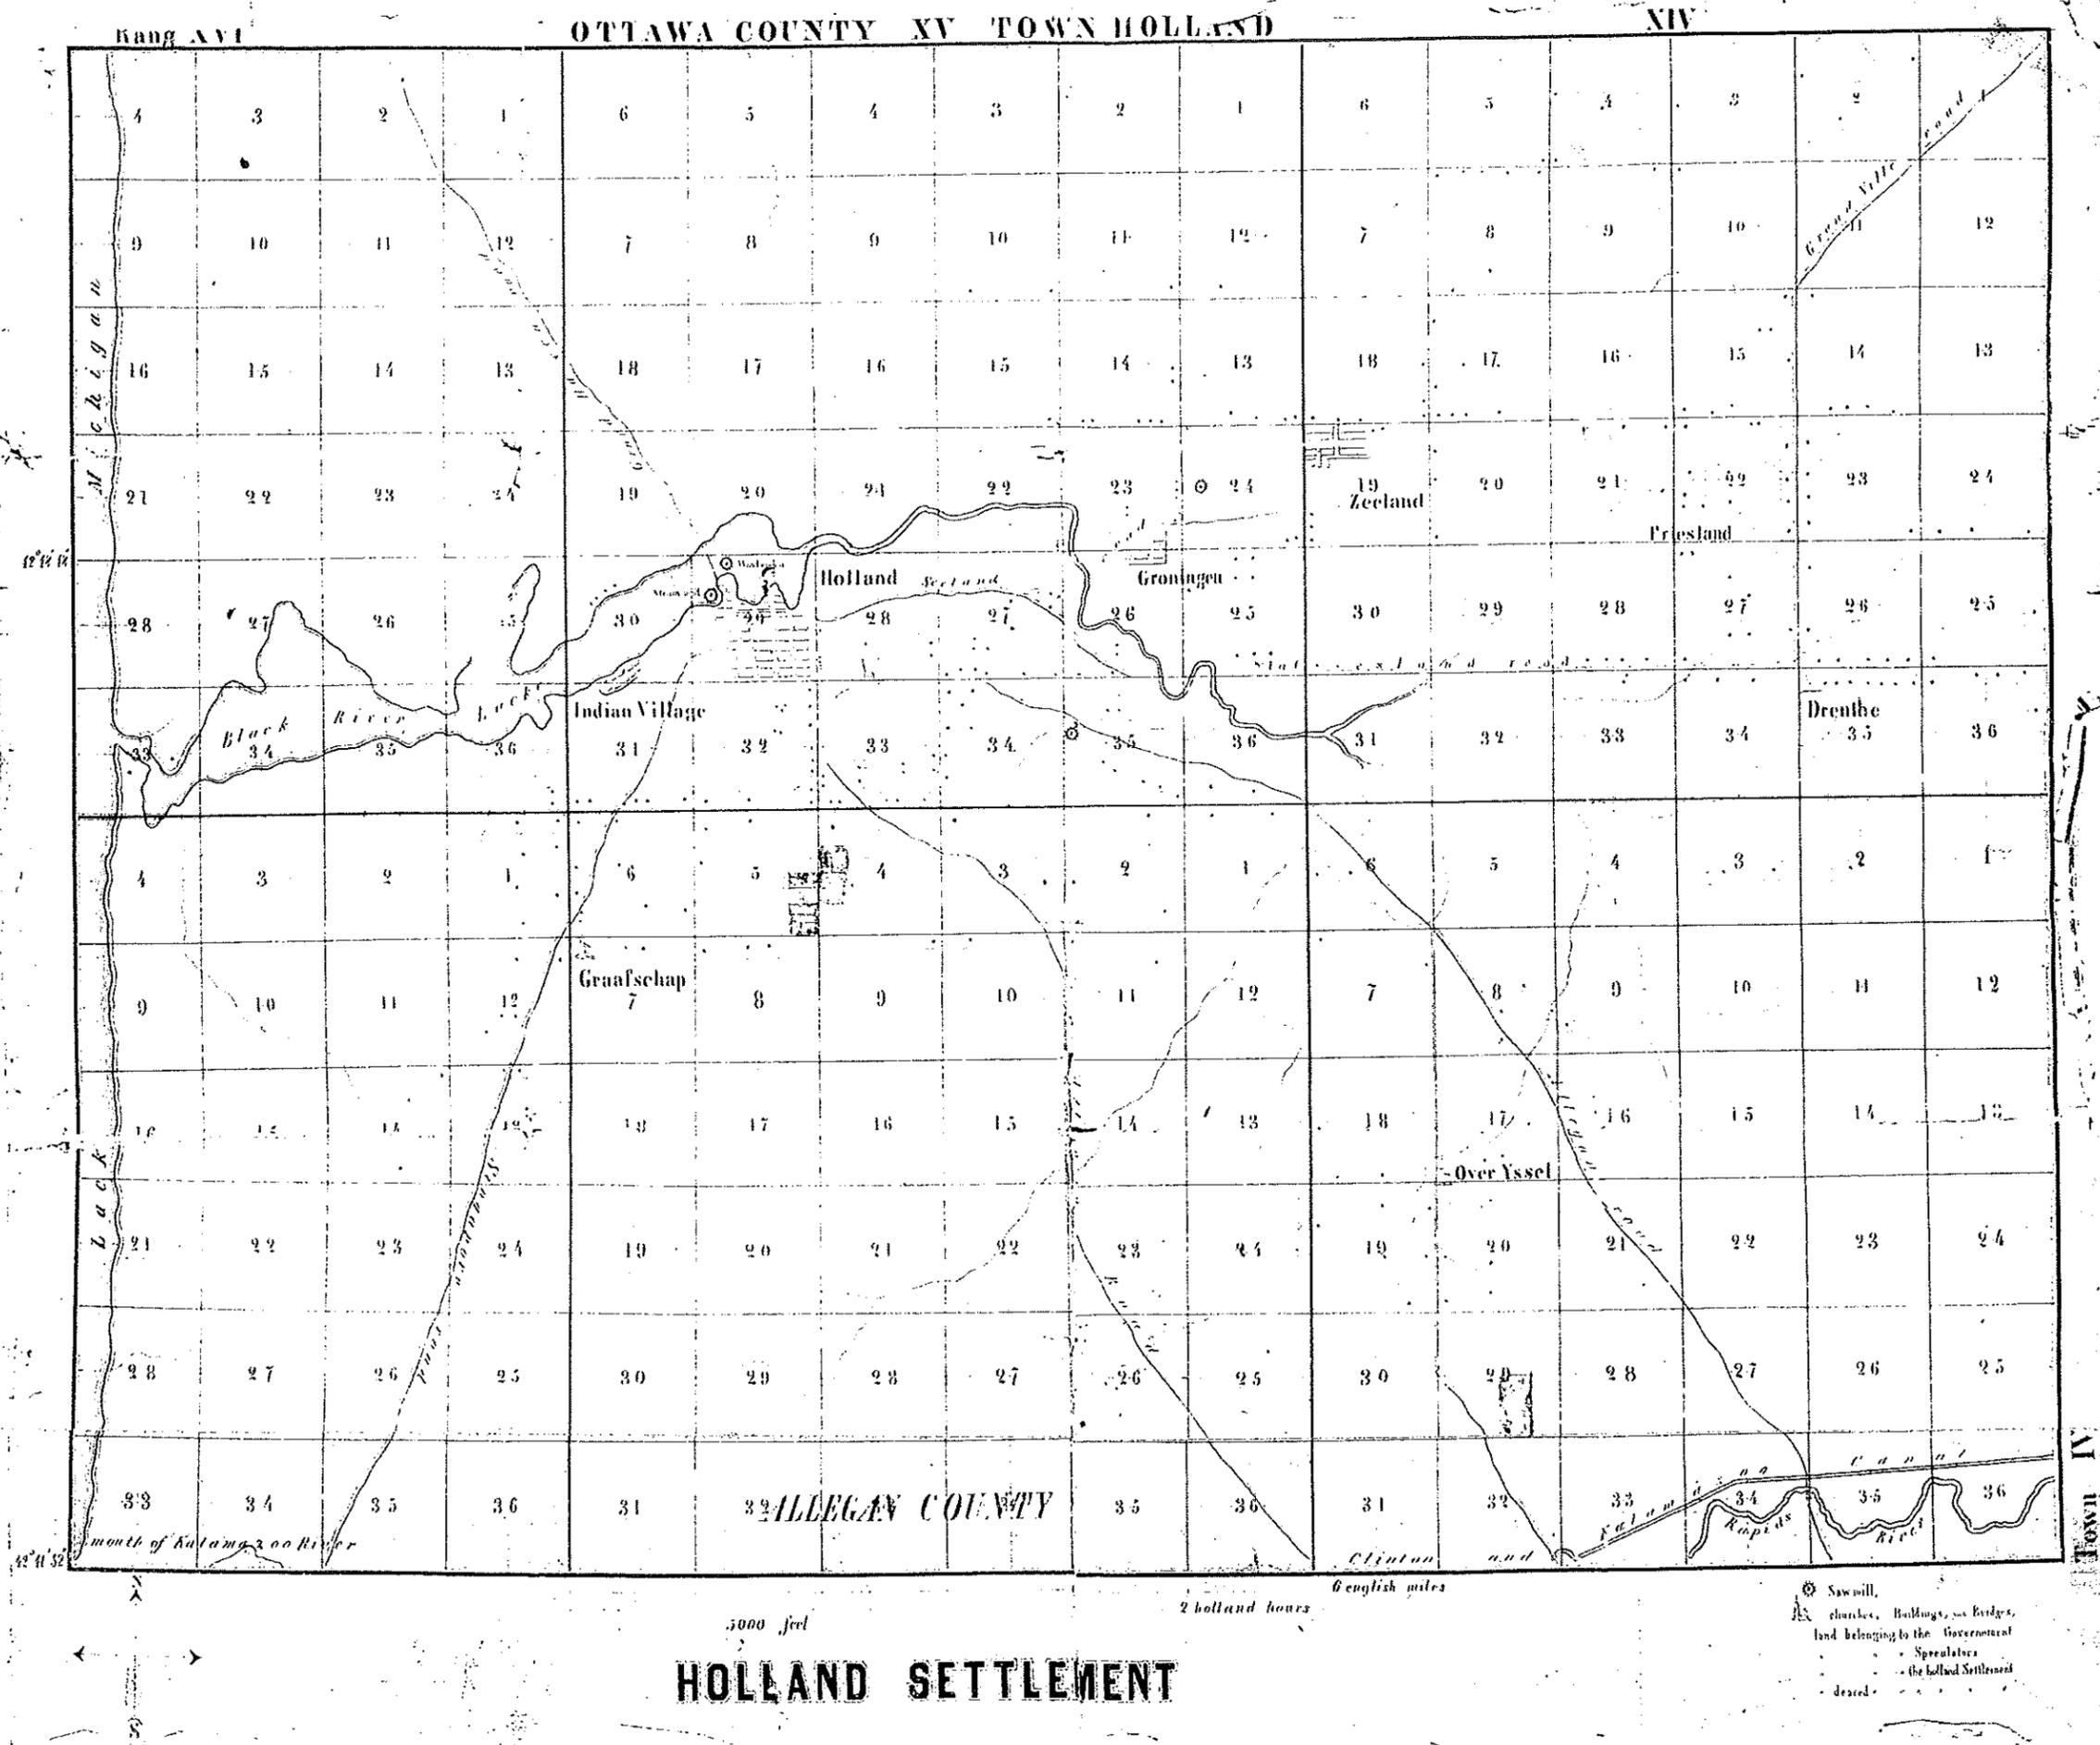
Figure 4: An early map of the Holland settlement. (Source: The Holland Museum Archives.)

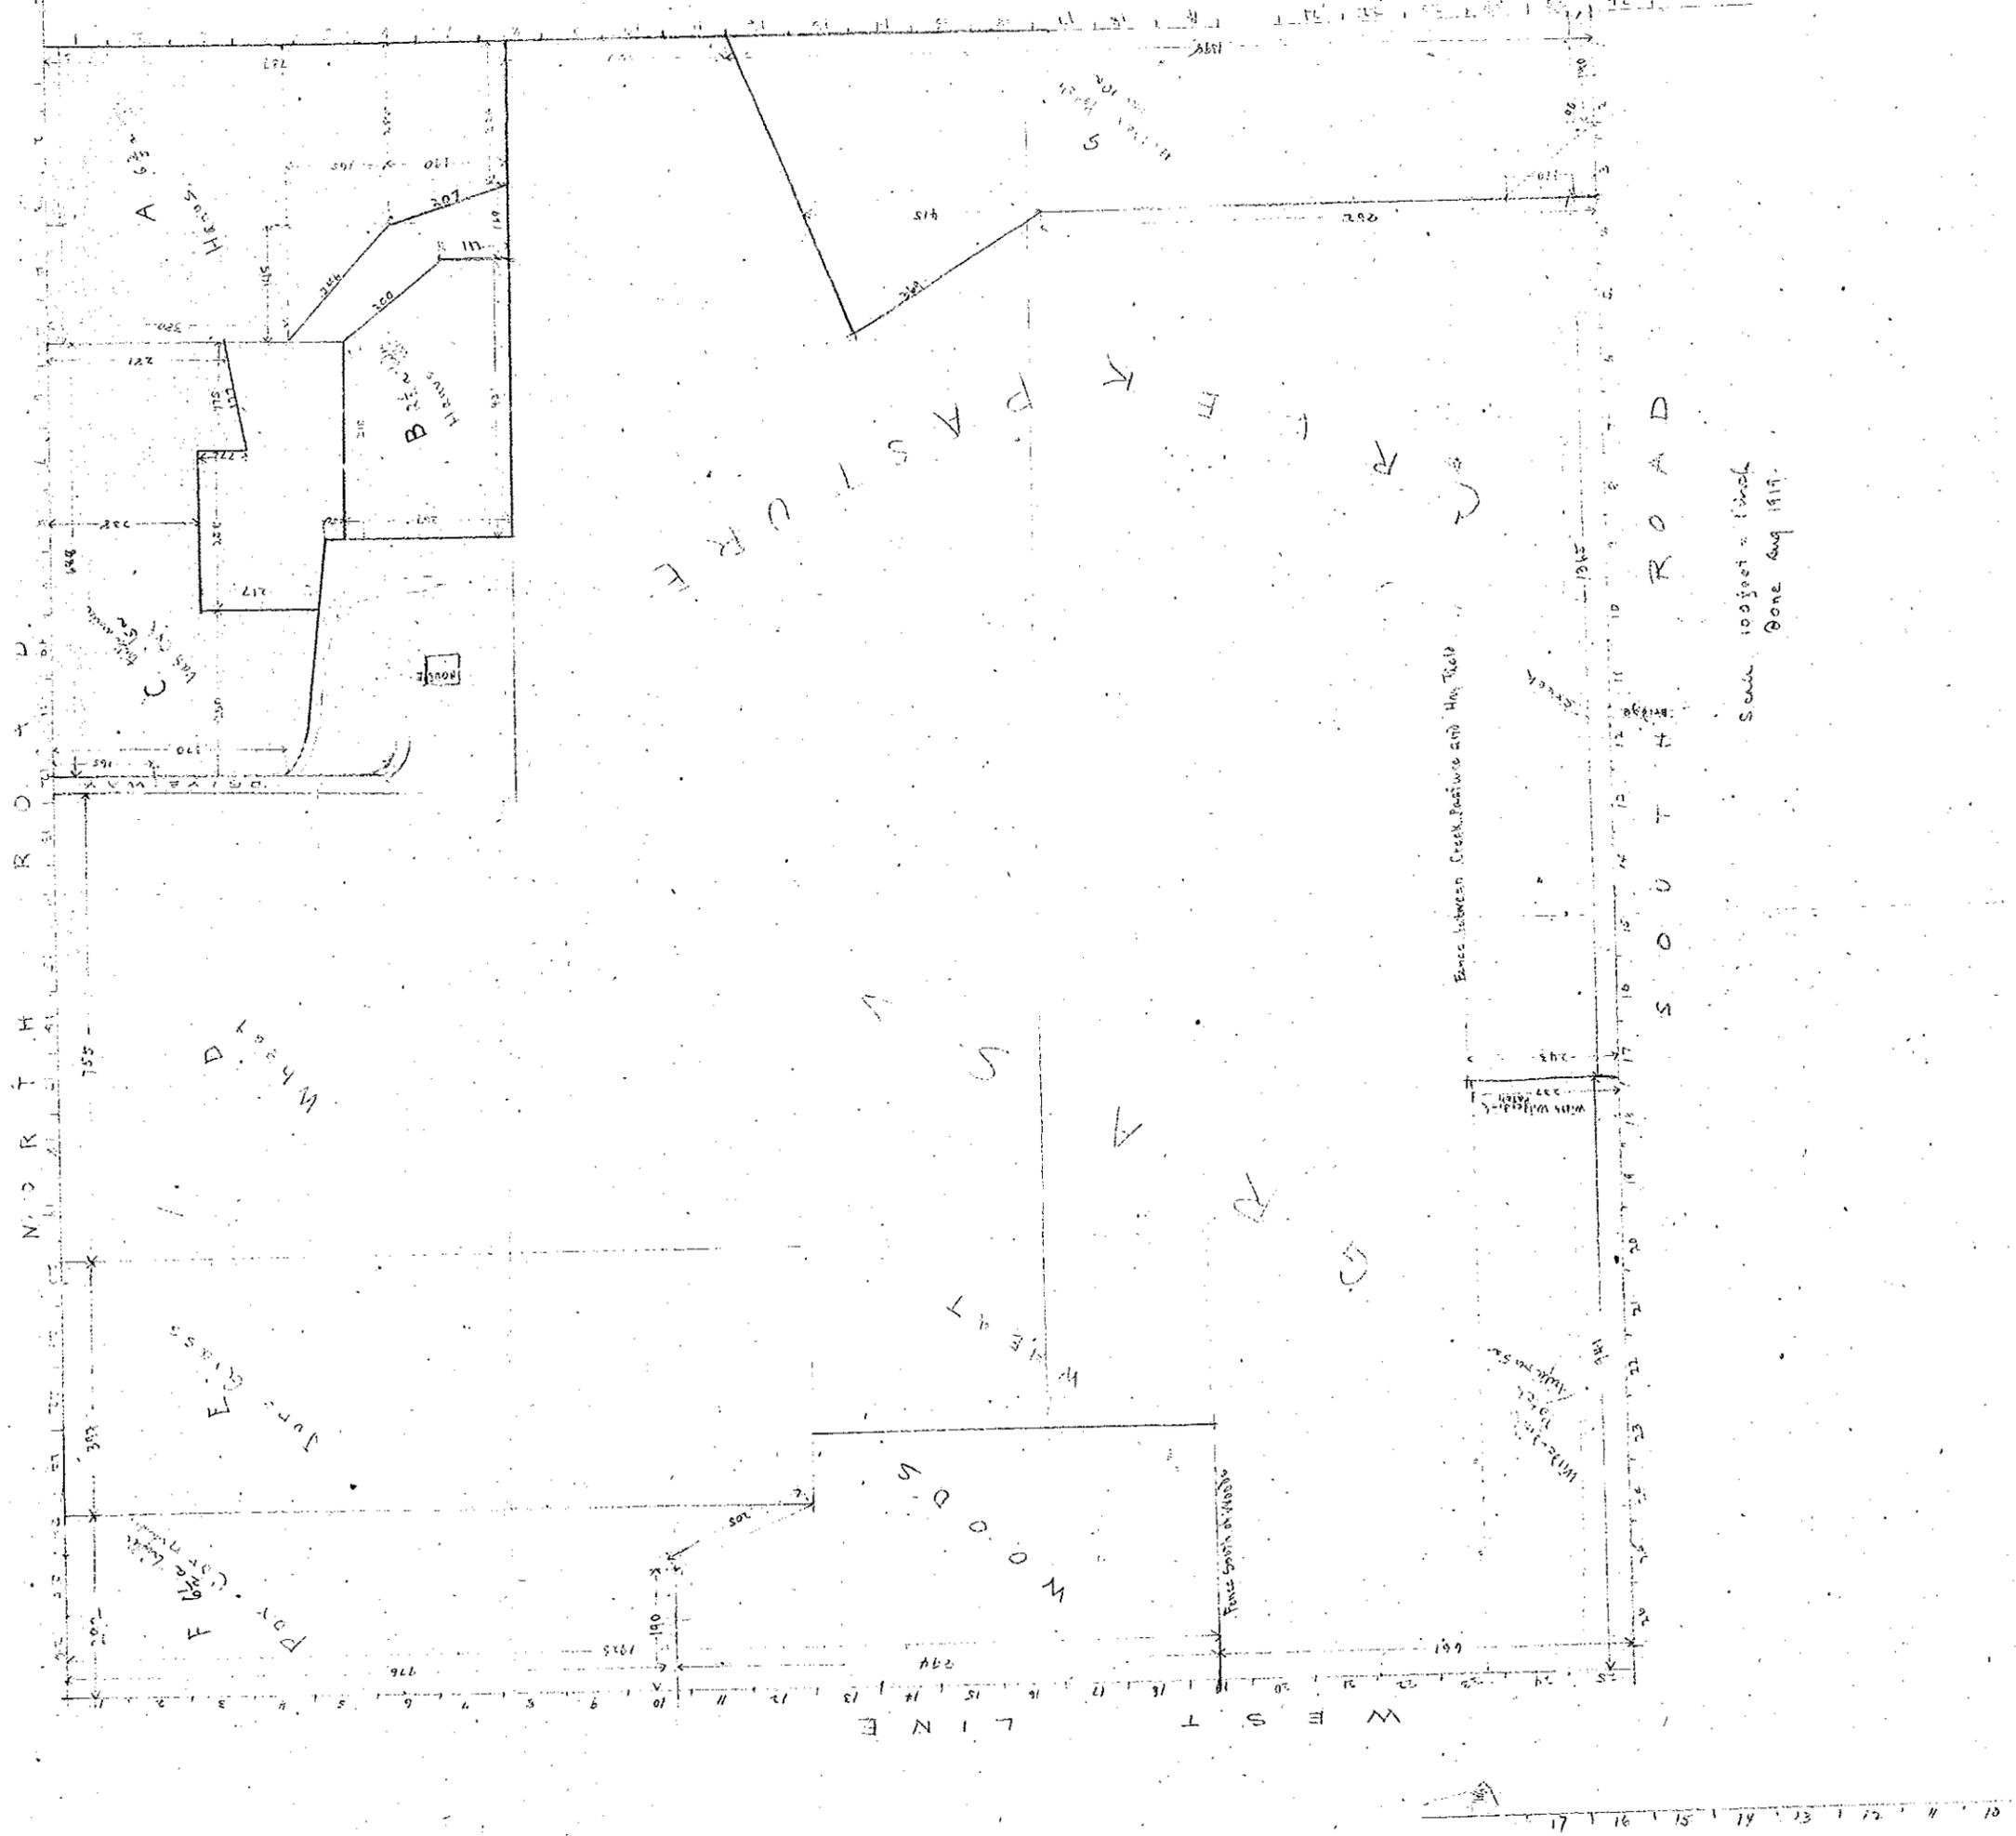
Figure 5: A drawing from 1919 showing divisions of the fields of the farmstead.
(Source: The Holland Museum Archives.)

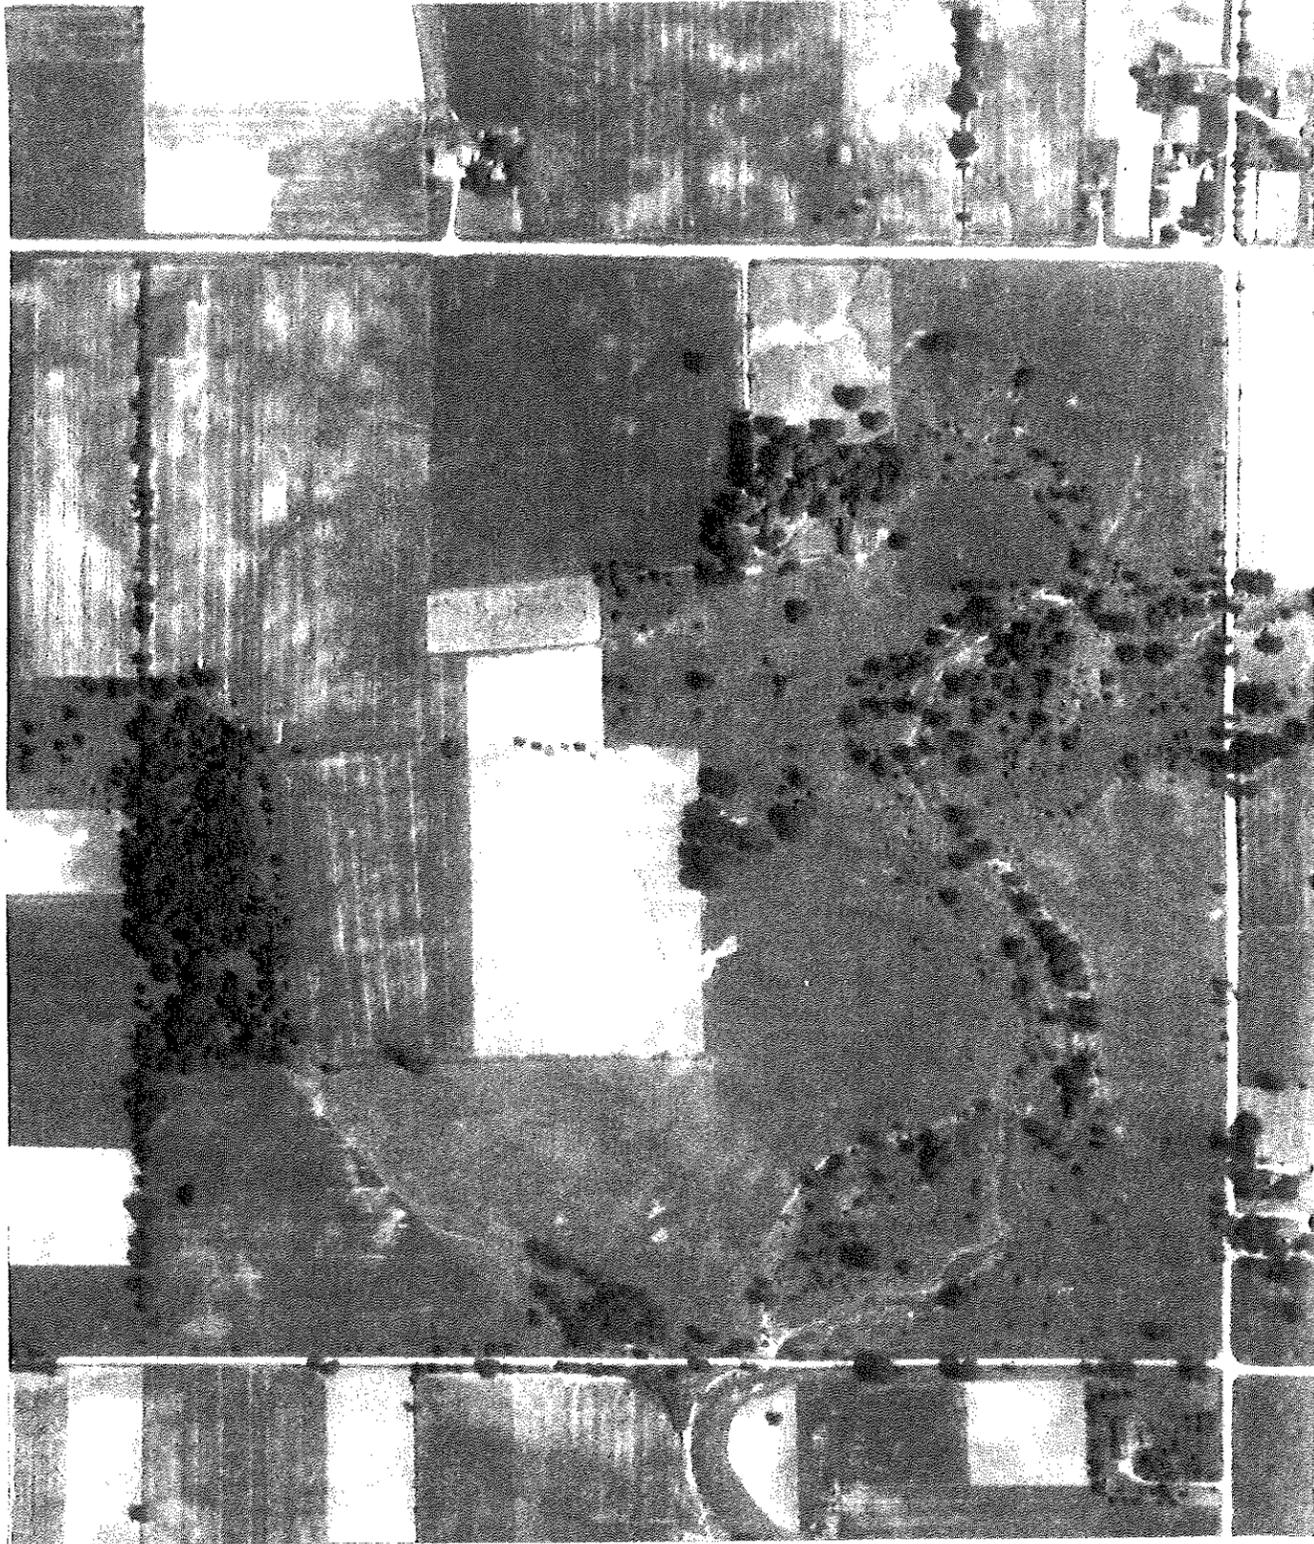
Figure 6: Aerial photograph including the farm from 1938.
(Source Michigan State University aerial photograph archives)

From the map of native plant communities in the Midwest, the original plant community was most likely beech-maple forest on the uplands and elm-ash forest in the wetland areas. The aerial photograph from 1938 shows the vegetation remaining after clearing of trees for the crop production. (Figure 6) The trees around the farmhouse which include predominately sugar maple form a relatively large stand of trees. The evergreen hedgerow on the west side of the entry drive is visible. A large woodland on the west property line is shown as left intact. This area is shown on the topography map with a small water feature within the woodland and with the 660 foot contour at both margins suggesting a wetland. This may be the reason the area was not cleared for crop production. Scattered trees and clumps of trees occur throughout the drainageways and river valley. A hedge row runs along the entire length of the west property line and scattered trees occur along the south and east property line. Several small trees and a tree at the entry drive are visible on the aerial photograph along the north property line. The drawing from the Holland Museum Archives from 1919 shows the division of the farmstead into fields and the associated crop and farmer renting the plot (Figure 5). The drawing indicates corn, June grass, and wheat on the western portion of the property and creek pasture on the eastern portion. The 1938 aerial photograph is a good record for showing the amount of clearing for the farm and the areas under cultivation. Figures 6 thru 11 show the progression of growth of the second generation forest.

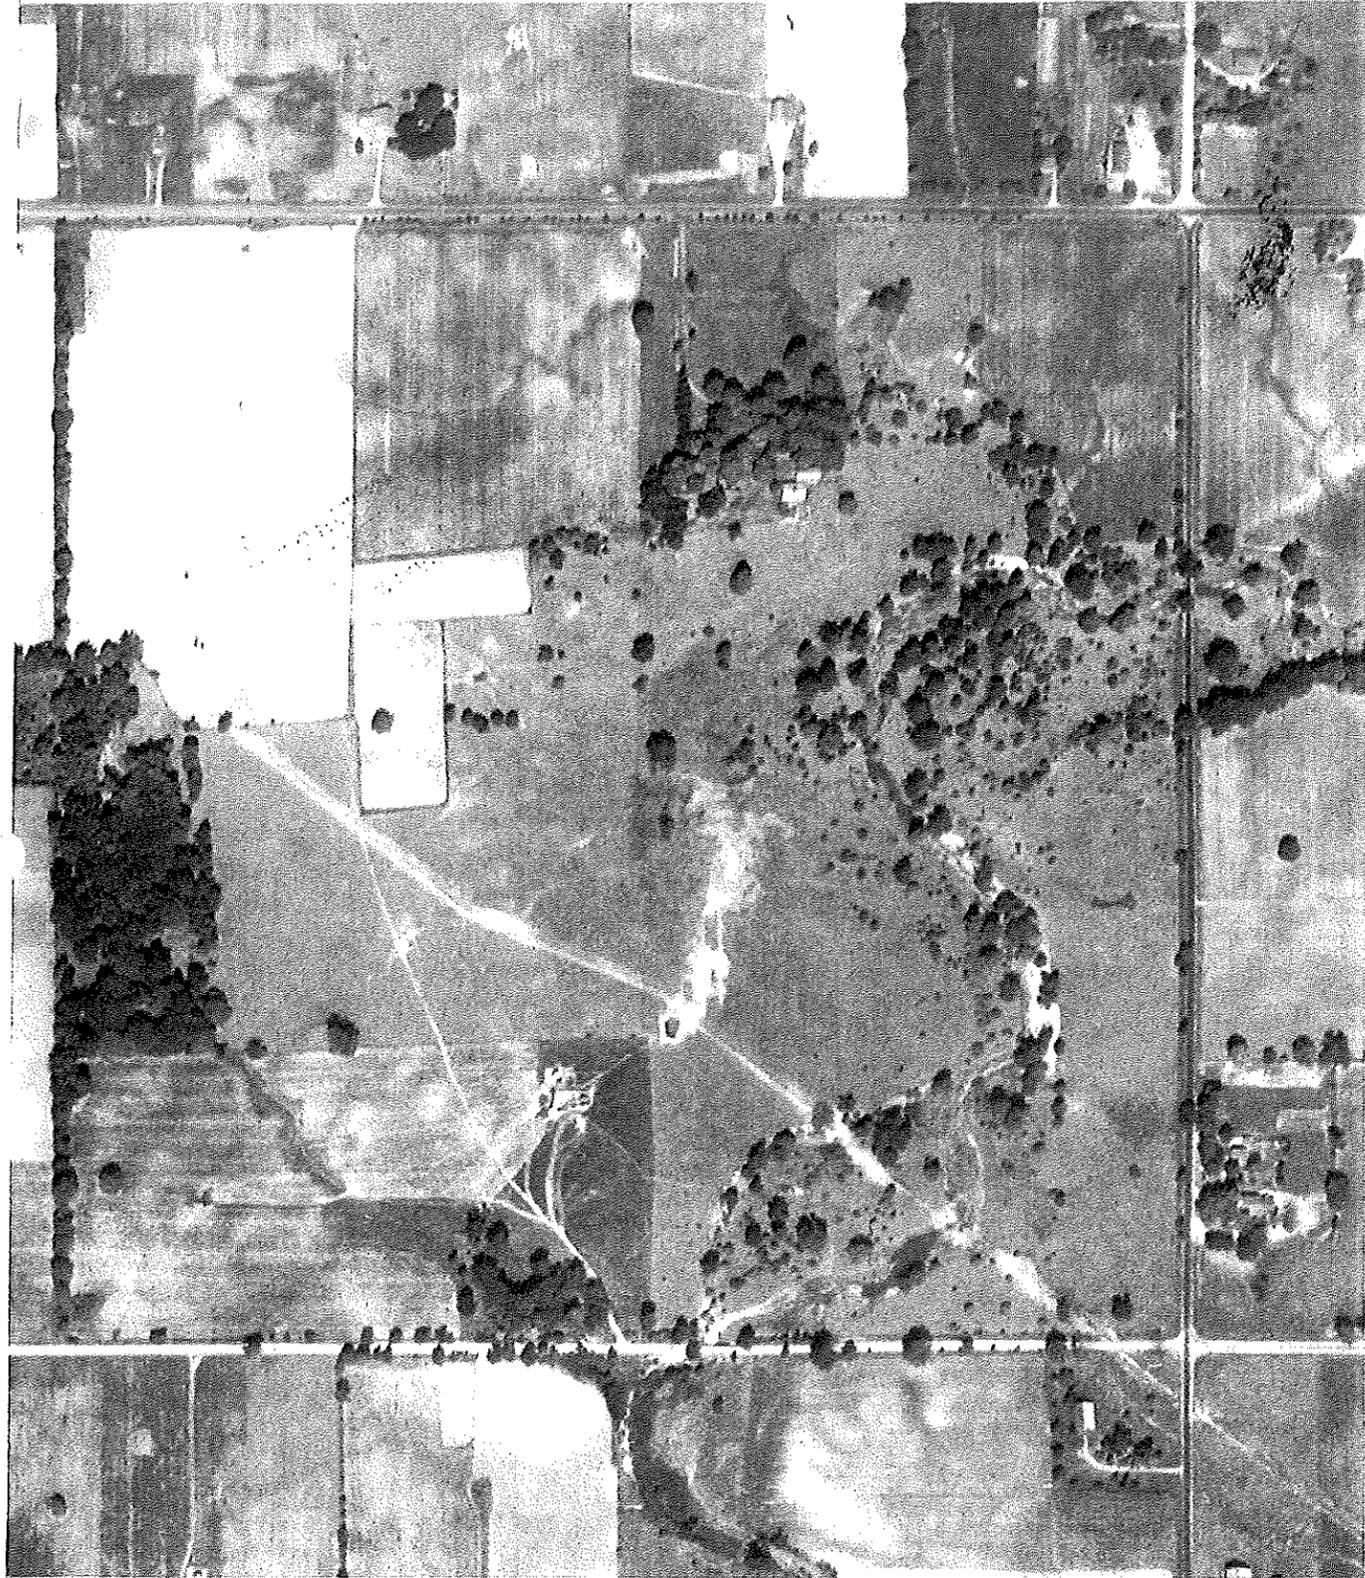
Figure 7: Aerial photograph including the farm from 1950.
(Source Michigan State University aerial photograph archives)

Subsequent aerial photographs show the progression of vegetation reclaiming the site up to 1974, nine (9) years before the land was purchased by the City of Holland (Figures 7 thru 11).

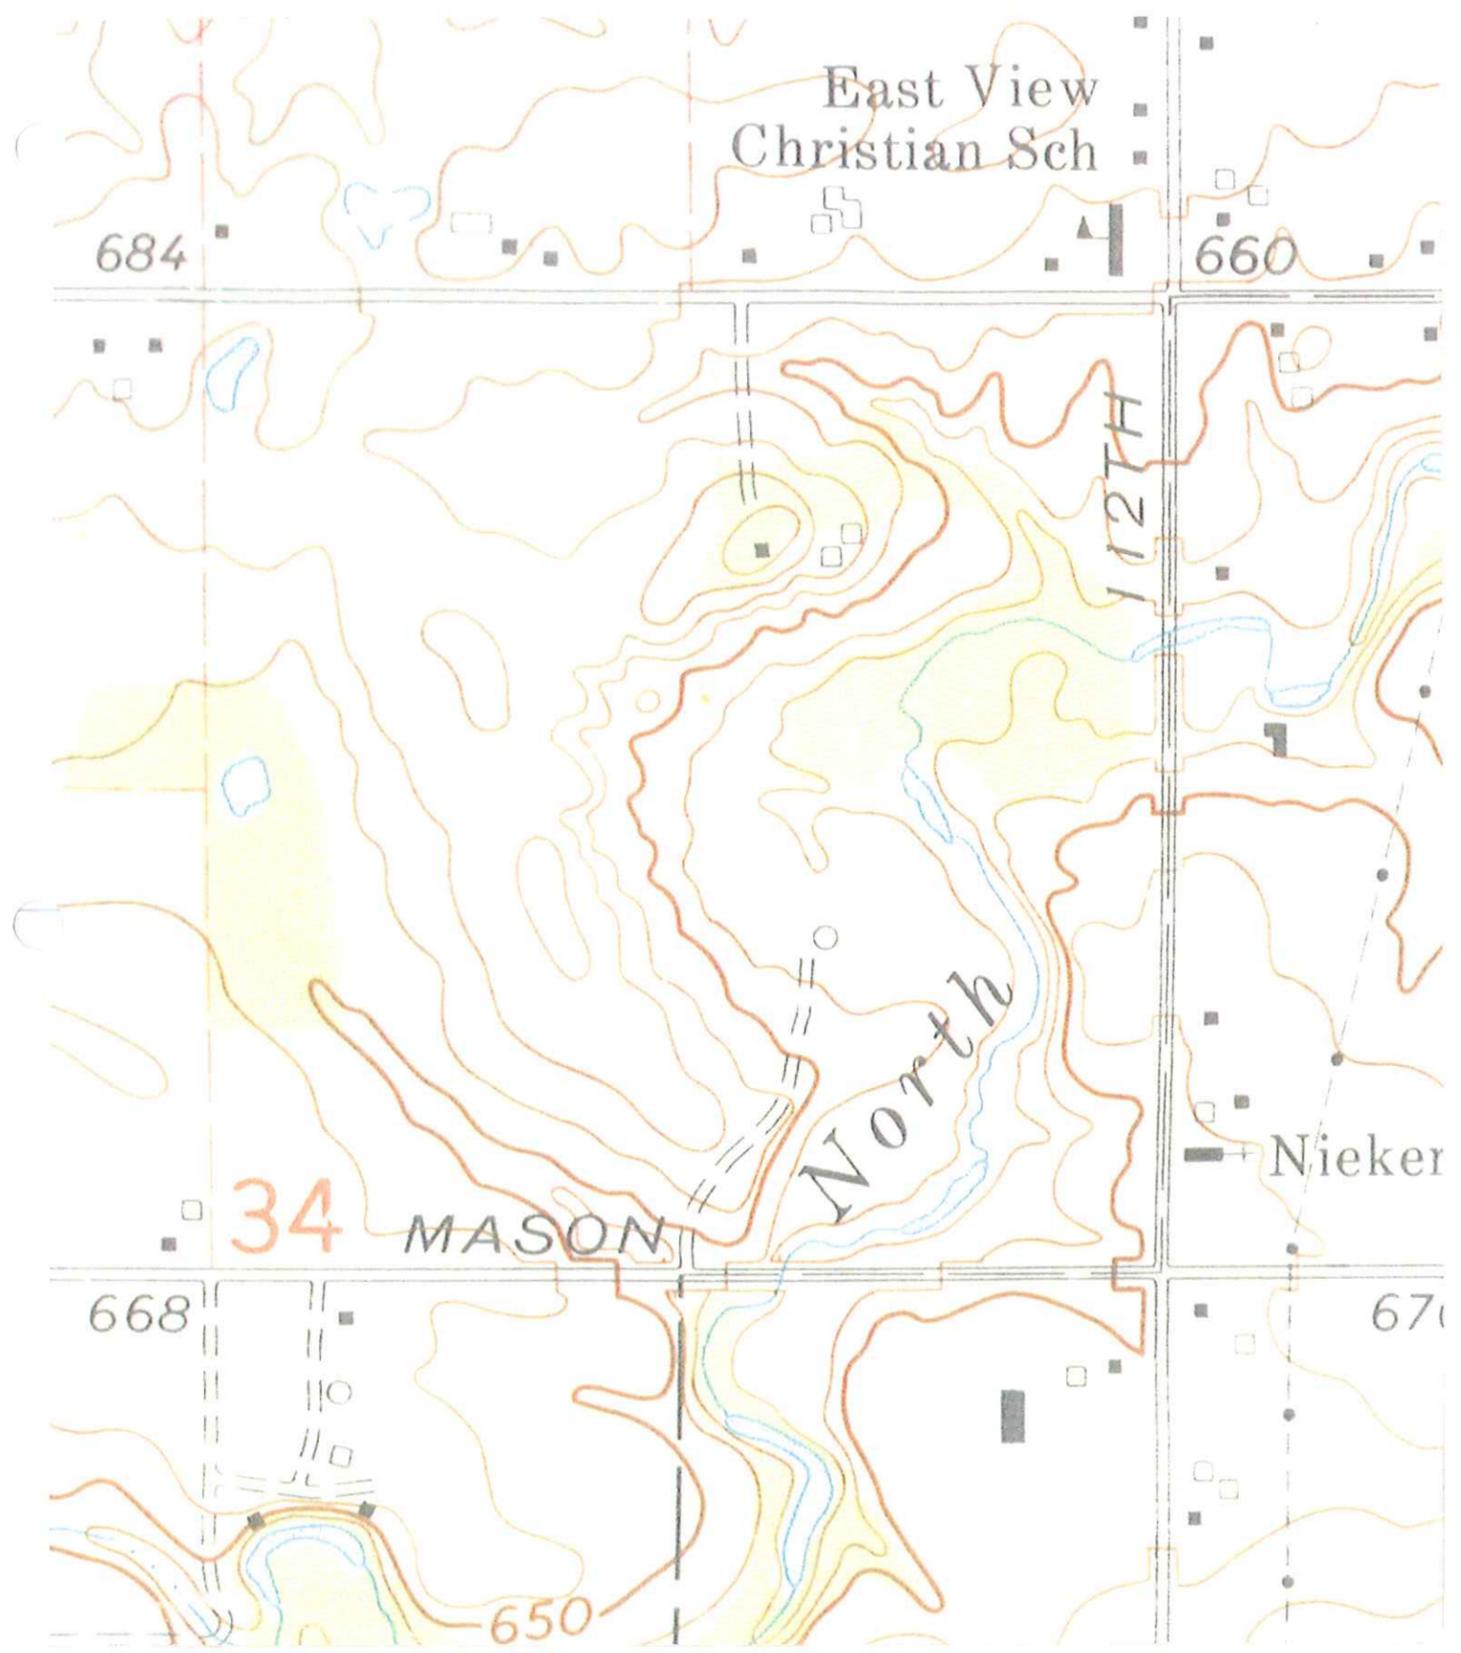
Figure 12: United States Geographical Survey topographical map – Holland East Quadrangle.

The original Van Raalte Farm is a microcosm of the Michigan landscape with the house sitting on top of a hill with an elevation of over 690 feet and the west fields with hillocks over 680 feet while the east portion forms a river valley with the North Branch of the Macatawa River meandering through from south to east (Figure 12).

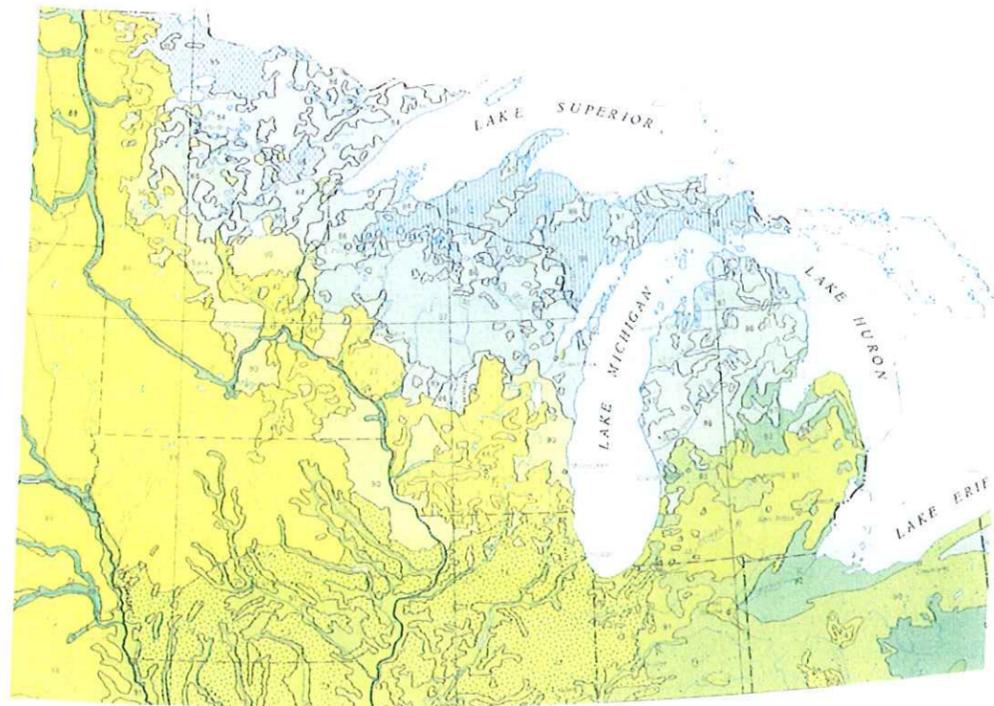
GRASSLAND AND FOREST COMBINATIONS

The native vegetation of the State of Michigan is predominately broadleaf forests in the southern half of the lower peninsula, Great Lakes pine forest in the northern half of the lower peninsula, and northern hardwoods forest and northern hardwoods-fir forest in the upper peninsula. The map of native plant communities in the Midwest (Figure 13) shows the distribution of these ecosystems.

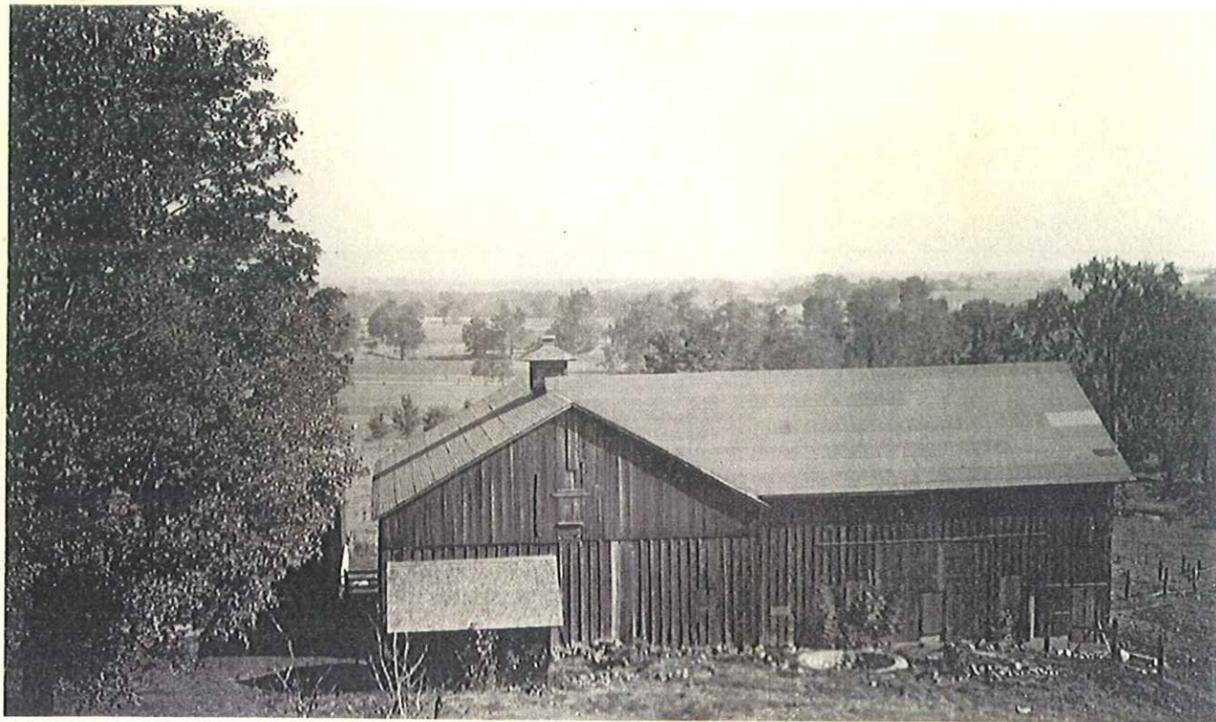
1705
Photograph #15: View of the south barn complex and fields beyond. (Note corn crib at north end, silo foundation, and farm fences).
