Cultural Landscape Report:

**The Van Raalte Farm
In
Holland, Michigan**

Prepared by J. Brian Devlin
January 2006

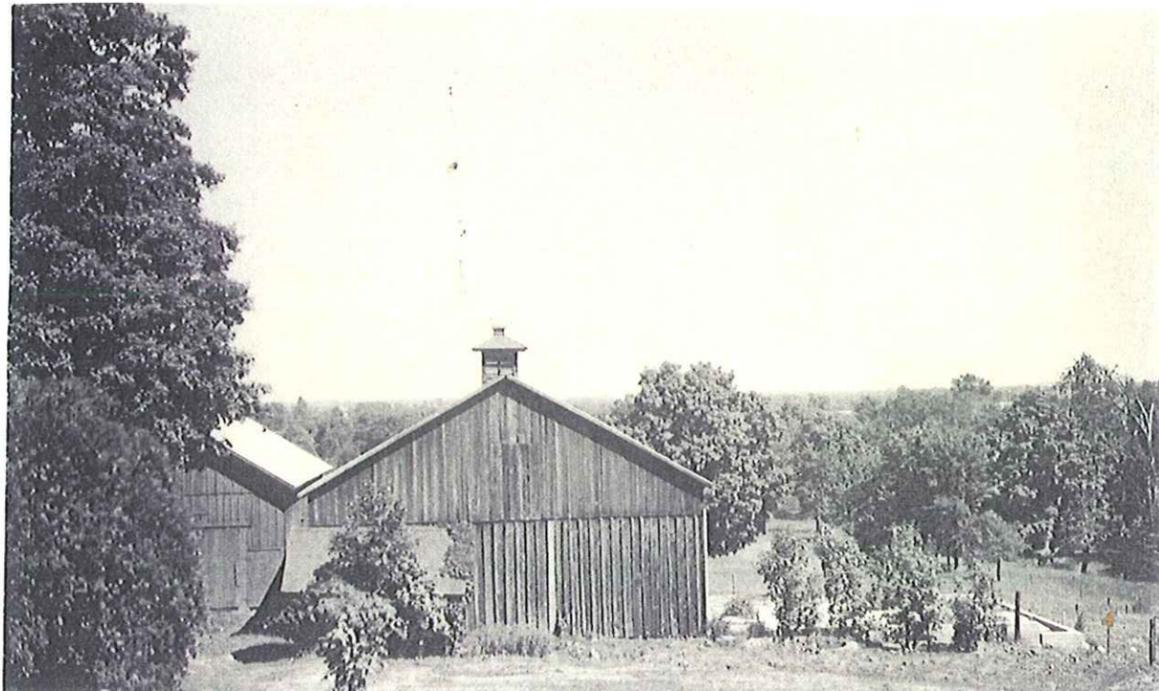
Photograph #16: View of the south barn complex with north-south wing removed and trees sprouting along the foundation.

Many young trees have grown into the foundations of the silo and north-south wing of the gray barn. Also, several maples originally preserved by the Van Raaltes have become so large that they extend over the existing barns and house.

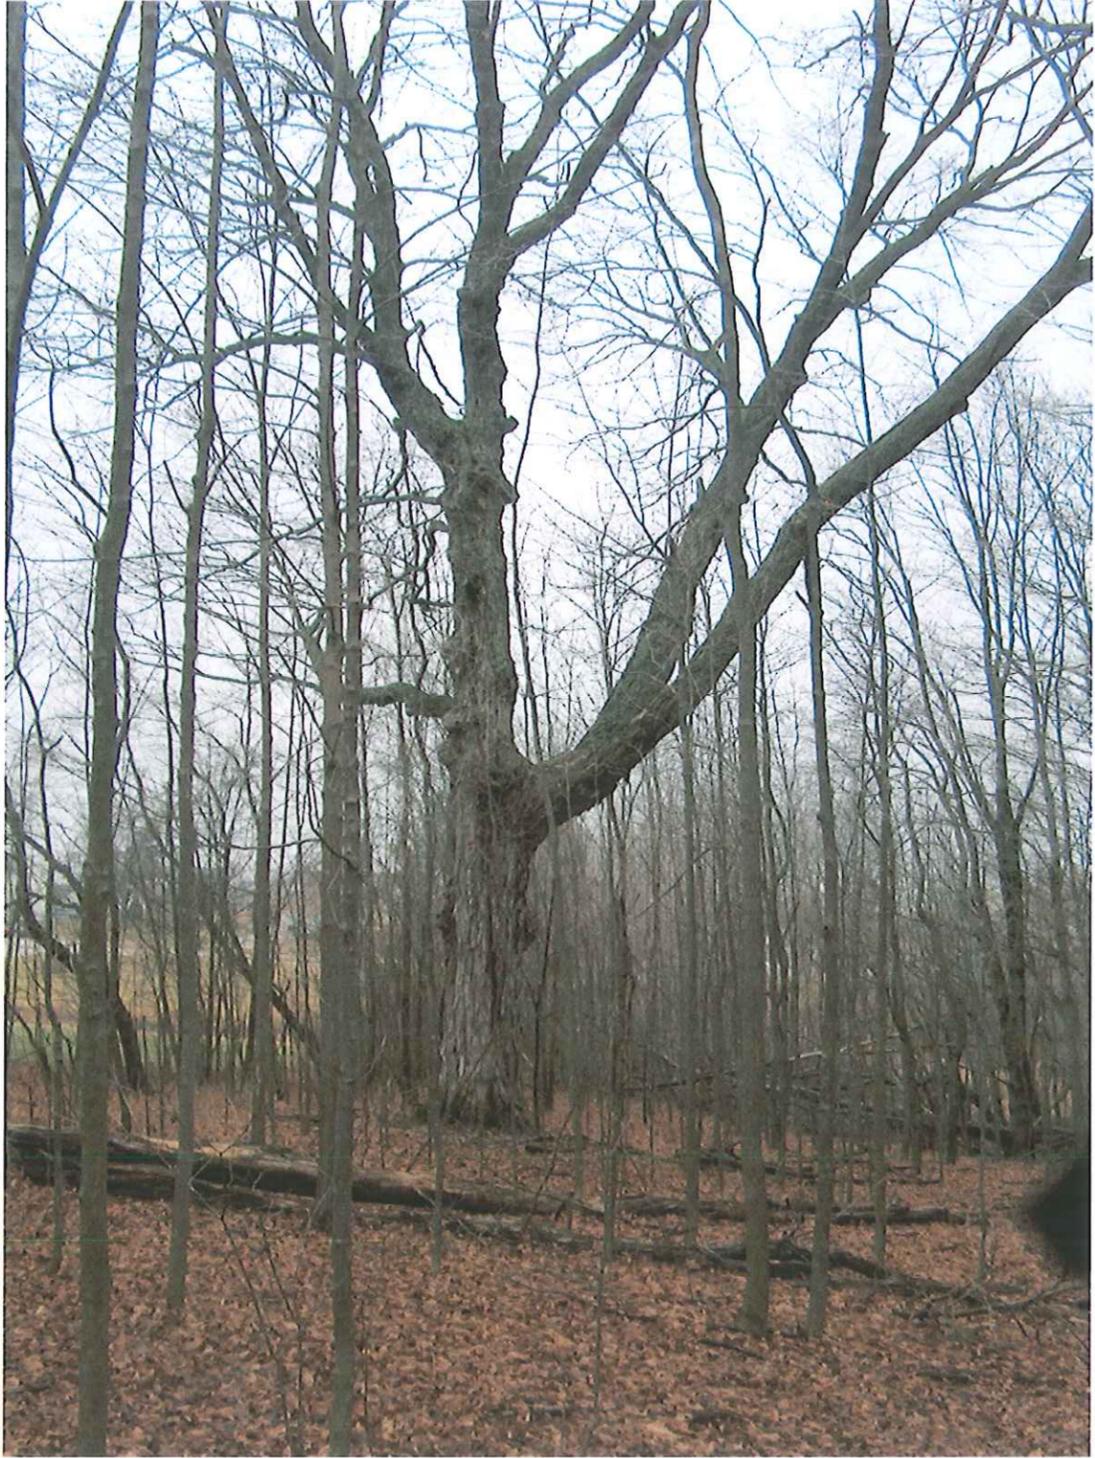
Photograph E 44: View of trees encroaching on silo and gray barn wing foundations.

- Photograph E 43: View of large trees overhanging red barn.
- Photograph E 44: View of trees encroaching on silo and gray barn wing foundations.
- Photograph E 44: View of trees encroaching on silo and gray barn wing foundations.

Any trees which pose a hazard to the barns because of their proximity to the barns should be removed, in particular, the ash tree immediately to the west of the gray barn. Trees growing into the foundation of the silo and gray barn wing should be removed immediately. A small swale should be dug to the west of the gray barn starting at the location of the corn crib in old photos at the northwest corner of the barn to direct water away from the base of the barn and prevent soil accumulation at the base of the barn.

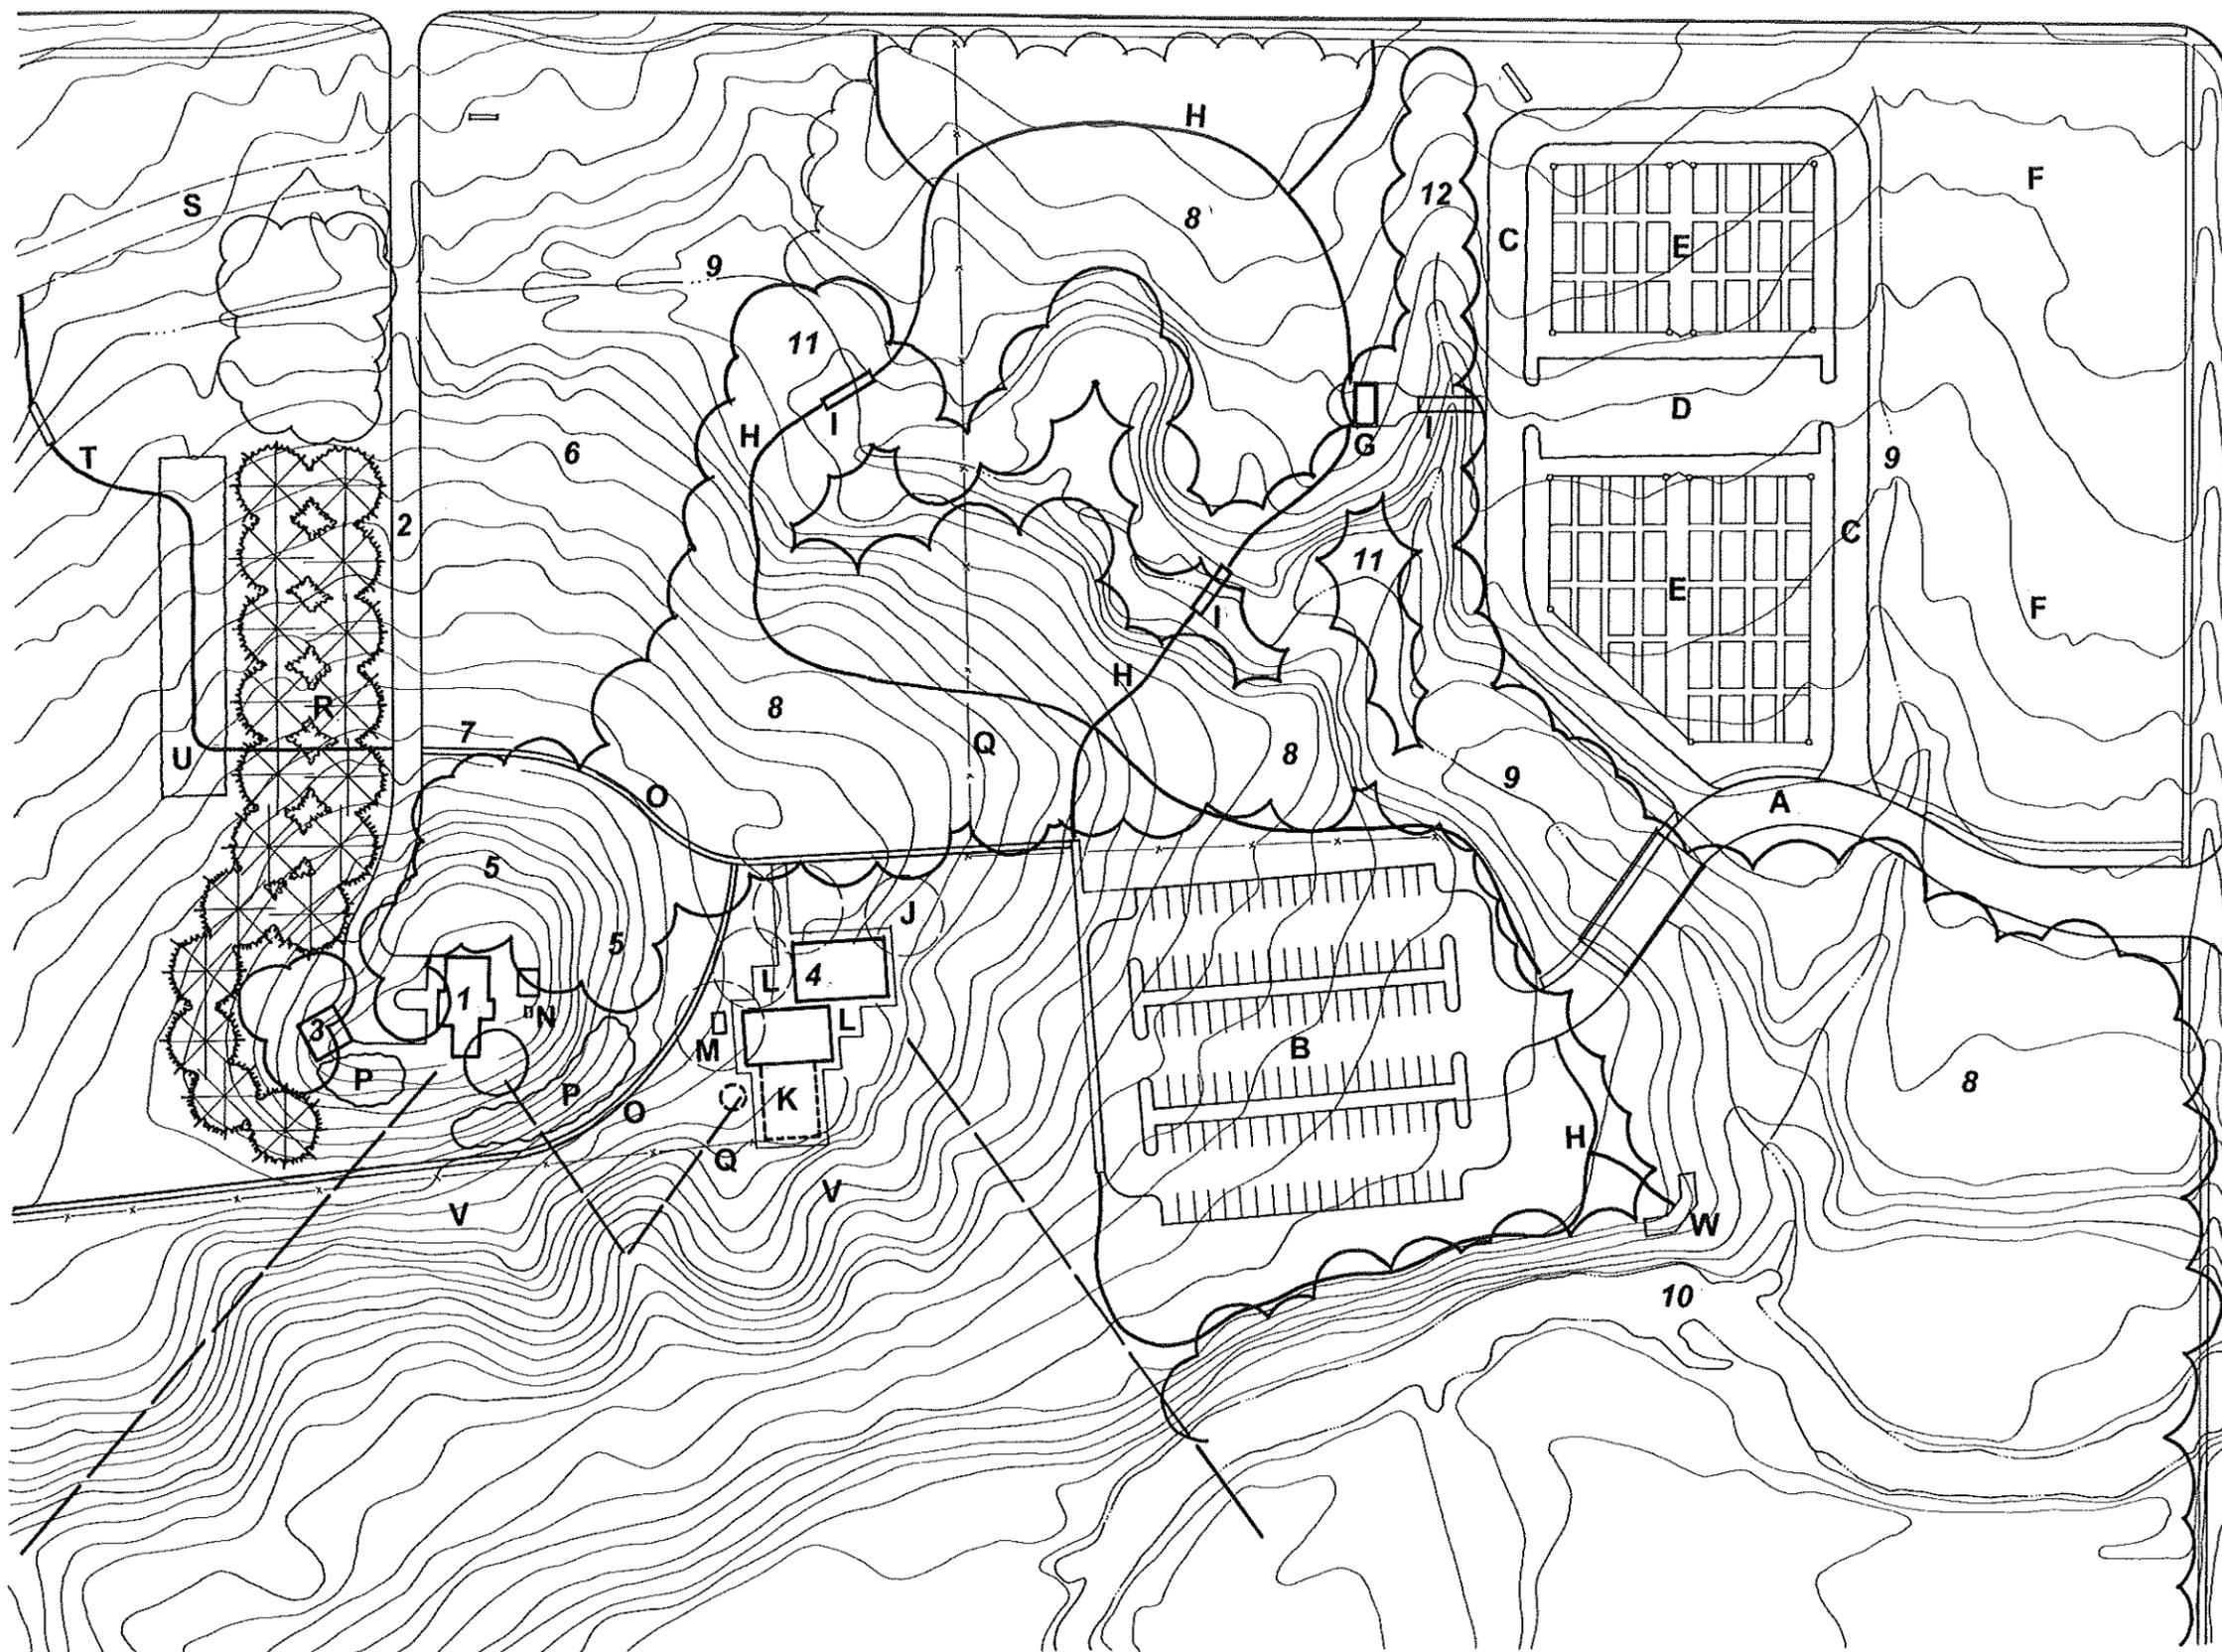
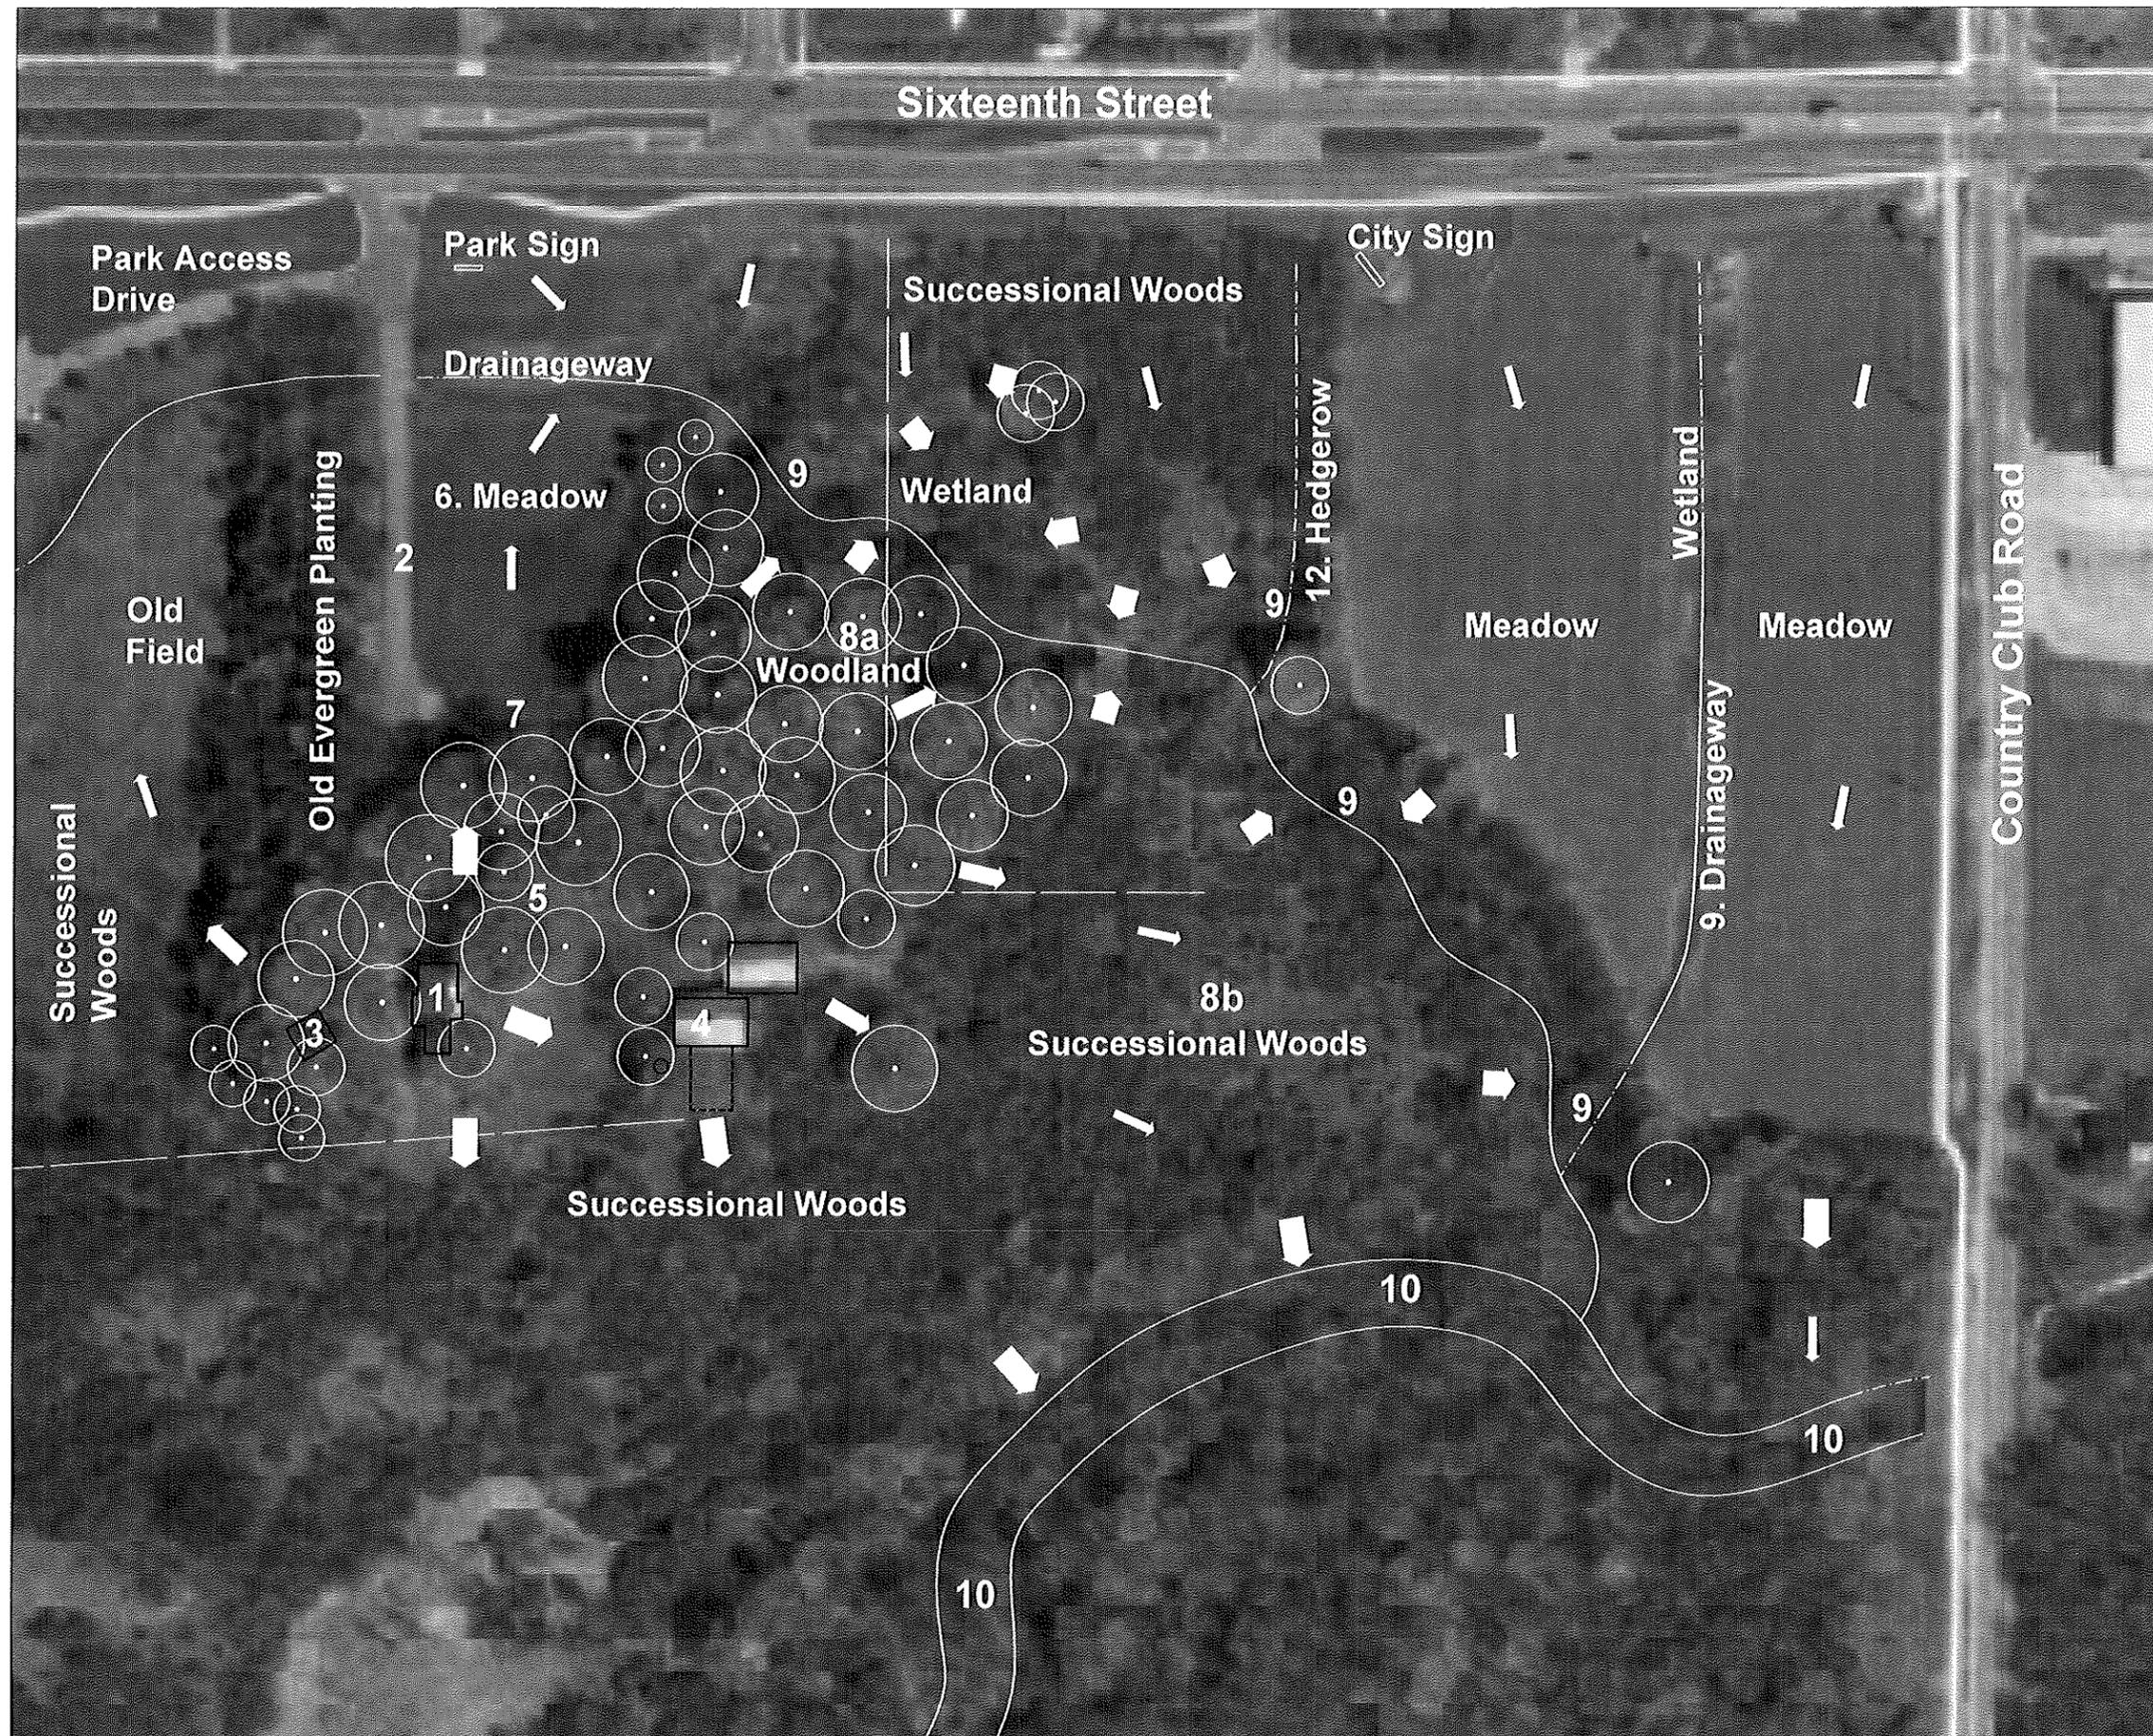
**LP - 1:
 HISTORIC SITE
 MASTER PLAN**

- A. Entry Drive
- B. Parking Lot
- C. Gravel Drive
- D. Gravel Parking Lot
- E. Community Gardens
- F. Pick Your Own Crops
Apples, Pumpkins,
Strawberries, Raspberries
- G. Relocated Shelter
- H. Woodland Trail
- I. Bridge
- J. Remove Trees Overhanging
Barns
- K. Restored Barn
- L. Concrete Pad
- M. Corn Crib
- N. Pumhouse and Windmill
- O. Two-track Path
- P. Gardens
- Q. Replace Original Fence Lines
- R. Remove Trees beneath
Evergreens
- S. Relocate Access to West
Parking Lot
- T. Path from West Parking Lot
- U. Peony Beds
- V. Open Viewsheds from House
and Barns
- W. Deck Overlooking Stream

1. Existing Farmhouse
2. Farm Lane
3. Garage
4. Bams and Barn Foundation
5. Hillside Plantings
6. Meadow
7. Gravel Road to Bams
8. a. Sugar Maple Woods
8. b. Successional Woods
9. Drainageway and Creek
10. Stream
11. Wetland
12. Hedgerow

The goal of the master plan is to preserve the historic home lot in the condition that existed while under control of the Van Raalte family. This will offer visitors a chance to experience life on the farm. The use of the land in the northeast corner for gardening will extend this experience to hands on satisfaction. The unique topography and natural features are also important elements of the farmstead which add to the historic character and provide a rich outdoor experience for the visitor.

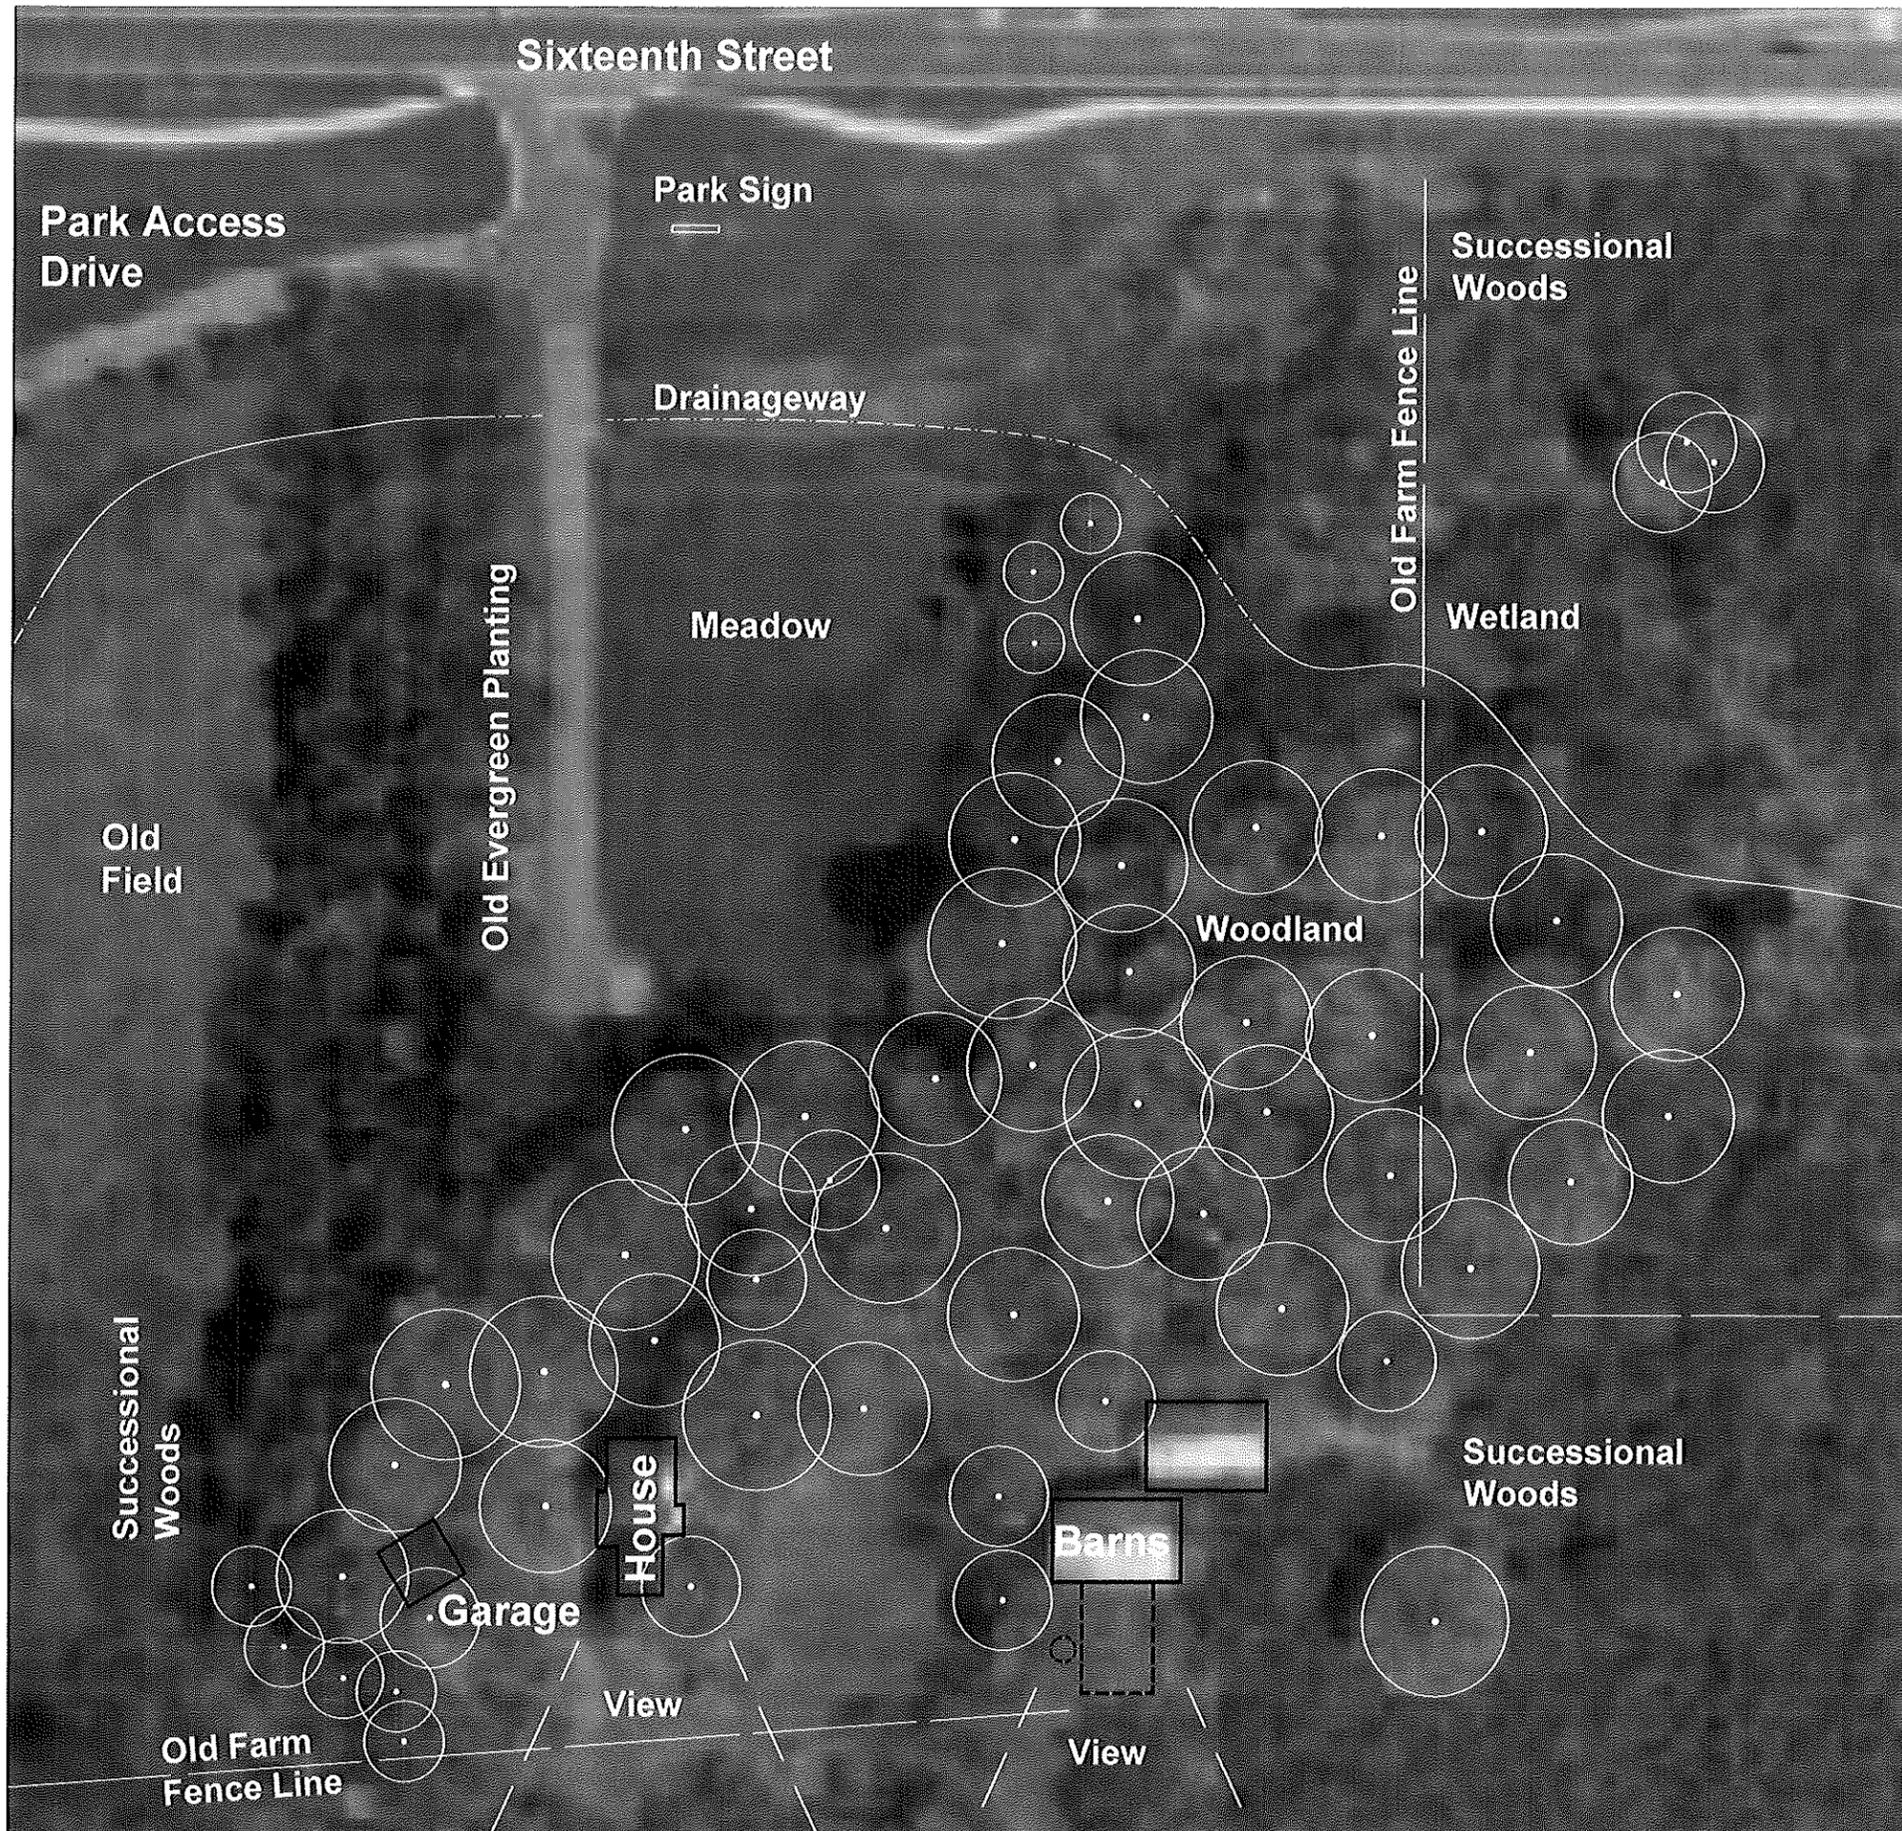
SP - 1: SITE ANALYSIS

DESCRIPTION OF ECOSYSTEMS

SUCCESSIONAL WOODS:

The successional woods is an ecosystem in transition from a fallow field to a mature woodland. This ecosystem at the Van Raalte Farm is dominated by sugar maple trees because of the abundance of seeds in close proximity. Other species observed include black cherry, hickory, ash, boxelder, hawthorn, dogwood, wild rose, and honeysuckle.

The woodland is a mature forest ecosystem dominated by large sugar maple trees with young sugar maples and saplings growing beneath. Wildflowers usually found in this ecosystem include trillium, Jack-in-the-pulpit, creeping strawberrybush, hepatica, Dutchman's breeches, and dog-tooth violet. The Beech-Sugar Maple forest is a climax ecosystem in lower Michigan, however, only a few beech trees were observed in this ecosystem.

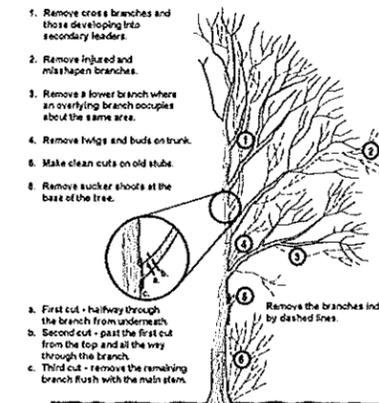
PROPER PRUNING TECHNIQUES not to scale

The existing shrubs around the farmhouse should be pruned regularly to maintain an ornamental quality and groundcover beds should be weeded periodically. Trees that become established at the foundation should be removed promptly. The maples on the hillside should be surveyed to determine exact locations for replacement in the future. Any dead wood should be removed from the existing maples and any branches overhanging the farmhouse should also be removed. The periwinkle groundcover bed should be weeded periodically.
